# Fire performance of thermal insulation products in end-use conditions

Comparative tests to assess the fire behaviour of a flat roof assembly with PIR and stone wool insulation products and a reinforced bituminous membrane below a PV system.

## Summary document

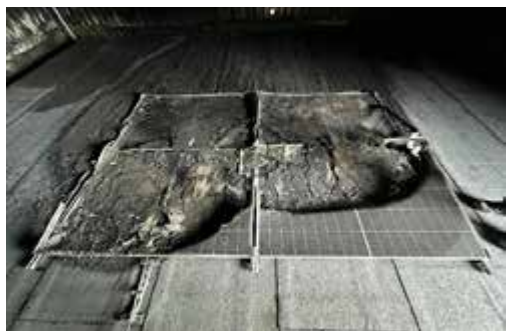
Across both tests, thermocouples in the locations, which were closest to the ignition source and the main direction of fire spread, recorded the highest temperatures. In general, thermocouples at the upper interface of the insulation (between the membrane and insulation) showed higher peak temperatures than those at the lower interface (between the two insulation layers and the vapour layers).

Twenty thermocouples were installed for each test. Nine were located between the roof membrane and the top of the insulation at a distance of 50 cm to the PV array and nine between the underside of the insulation and the vapour control layer below the PV array. Two were placed within the burn hall to monitor hot-gas temperatures at 4 m and 4.5 m above the floor. A data logger recorded all temperatures throughout the tests. Three video cameras captured views from different positions within the hall.
