Fire performance of thermal insulation products in end-use conditions

Comparative tests to assess the fire behaviour of a flat roof assembly with PIR and stone wool insulation products and a reinforced bituminous membrane below a PV system.

Summary document

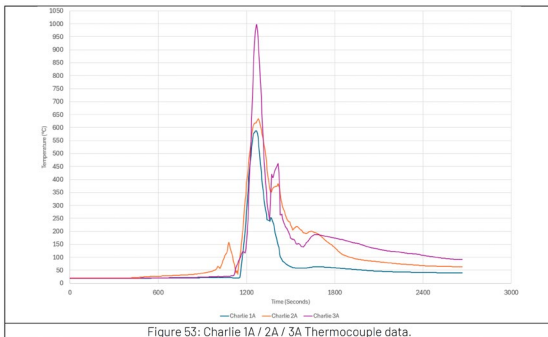
Stone wool insulated roof

The stone wool test showed higher recorded temperatures at most thermocouples within the roof assembly. One sensor recorded a peak temperature above 1200°C, which is assumed to be due to molten bitumen coming into direct contact with the thermocouple. Even excluding this local effect, maximum temperatures 50 cm from the PV array in the south direction were consistently higher in the stone wool test than in the equivalent locations in the PIR test.

Temperatures between the roof membrane and the insulation layer

Across both tests, thermocouples in the locations, which were closest to the ignition source and the main direction of fire spread, recorded the highest temperatures. In general, thermocouples at the upper interface of the insulation (between the membrane and insulation) showed higher peak temperatures than those at the lower interface (between the two insulation layers and the vapour layers).
