# FIRE RESEARCH AND TESTING REPORT

REFERENCE NUMBER: FPA/ 107586

This research was to assess the fire performance and behaviour of two different insulation products within a flat roof assembly with reinforced bituminous roofing membranes while being exposed to a PV solar panel fire.

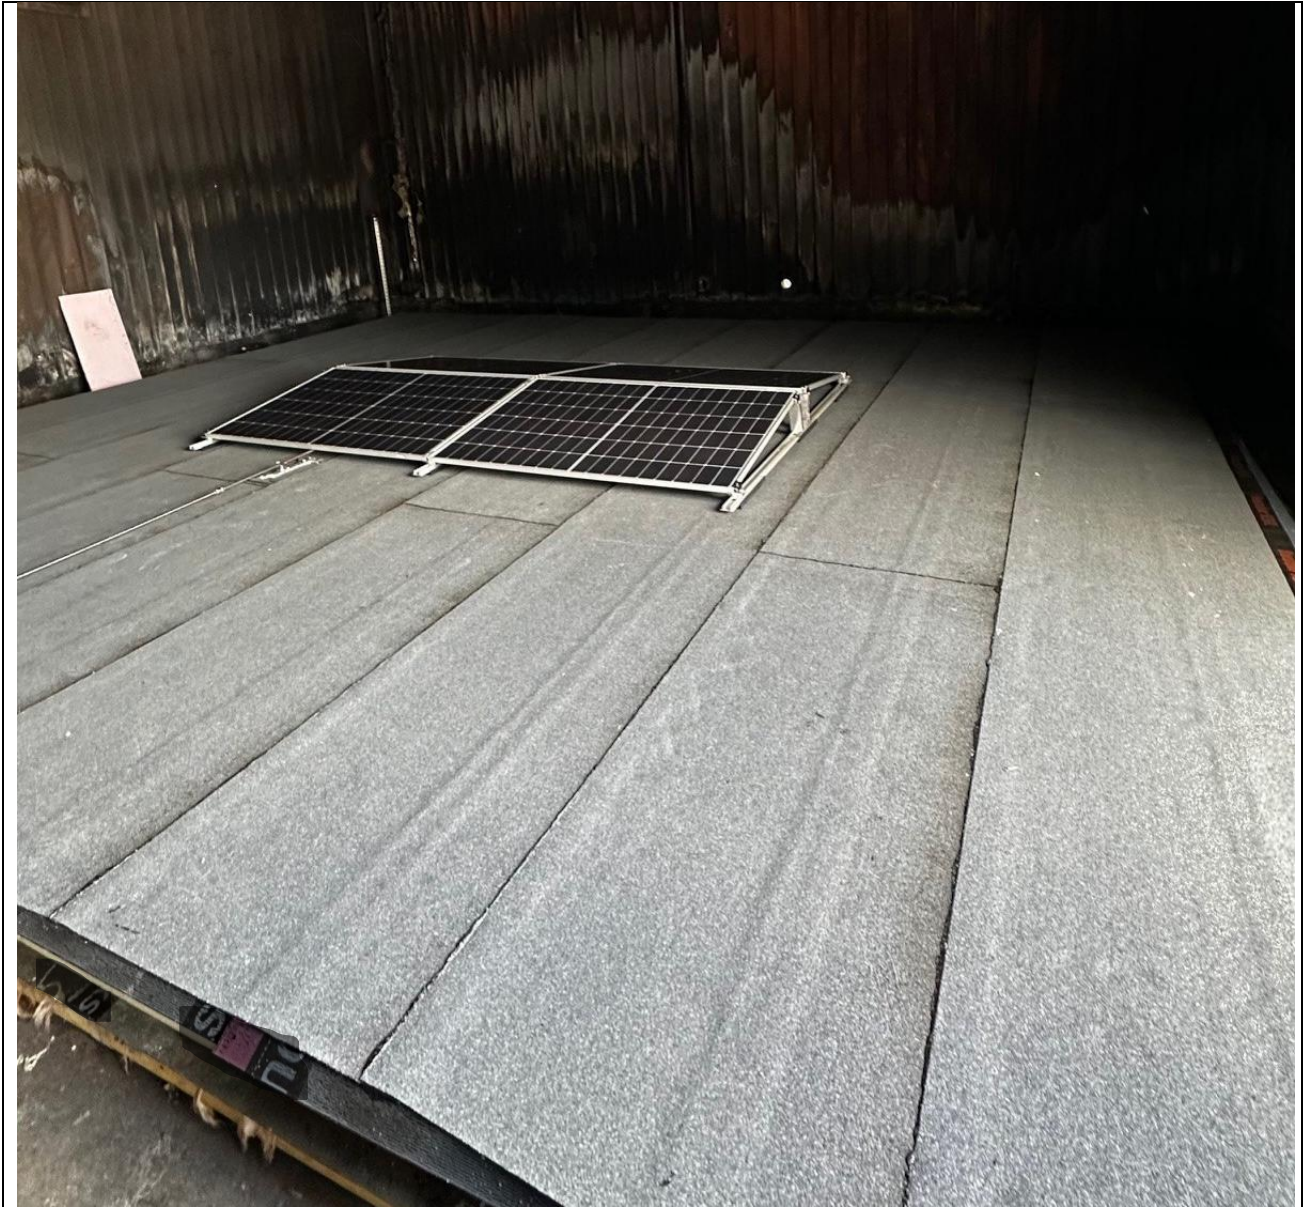
Figure 1: PIR insulation test roof assembly and set-up of solar panels.

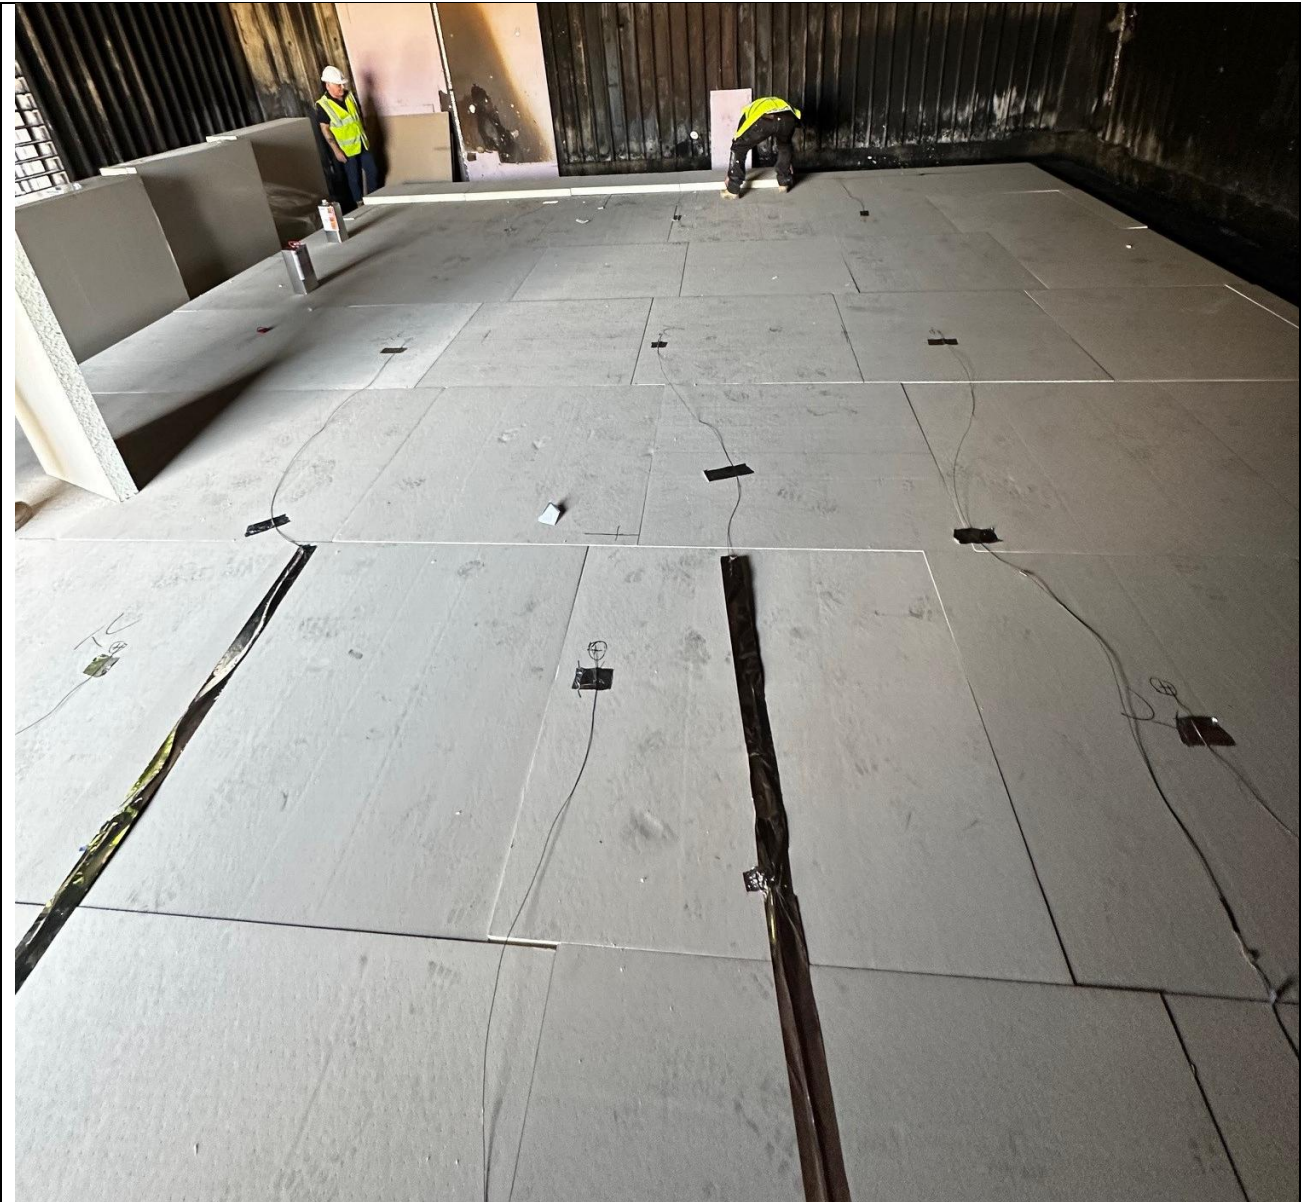
Figure 2: PIR insulation assembly and thermocouple layout.

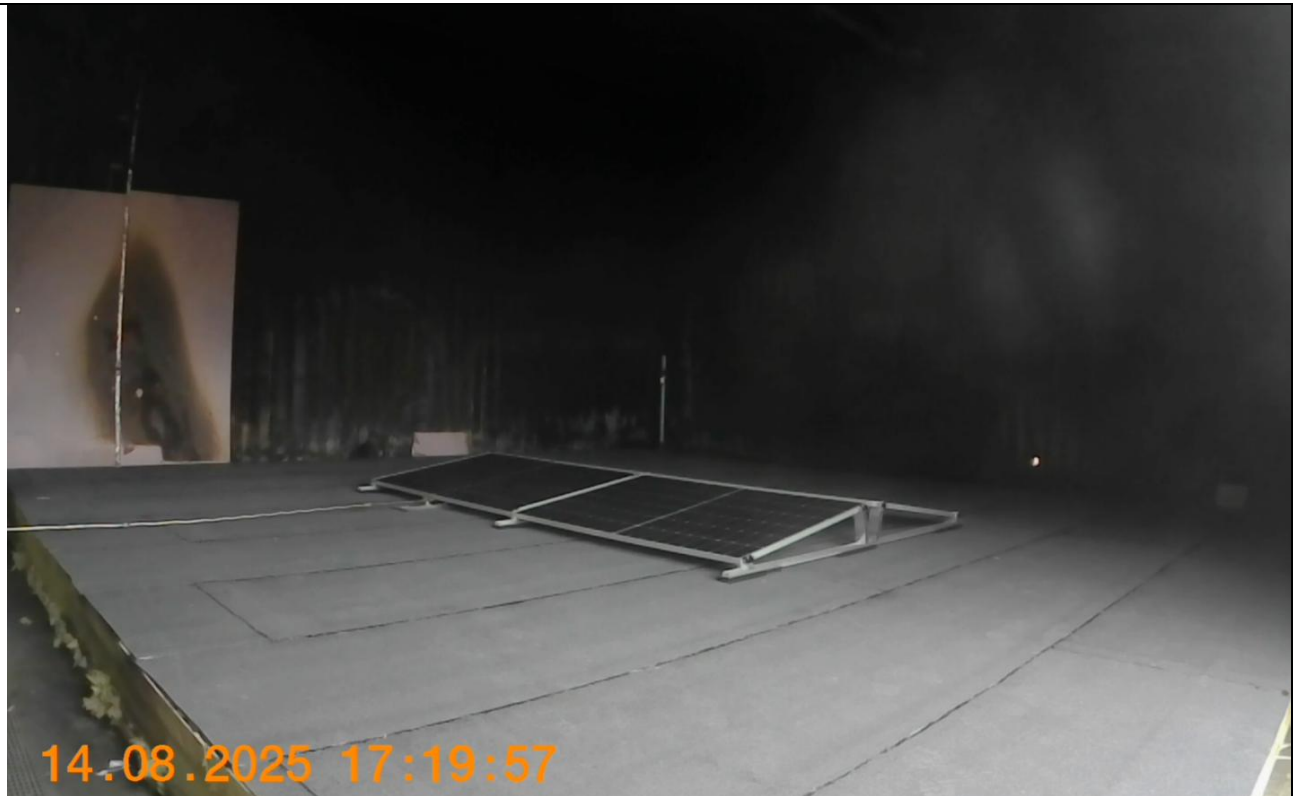
Figure 3: Stone wool insulation test roof assembly and set-up of solar panels.

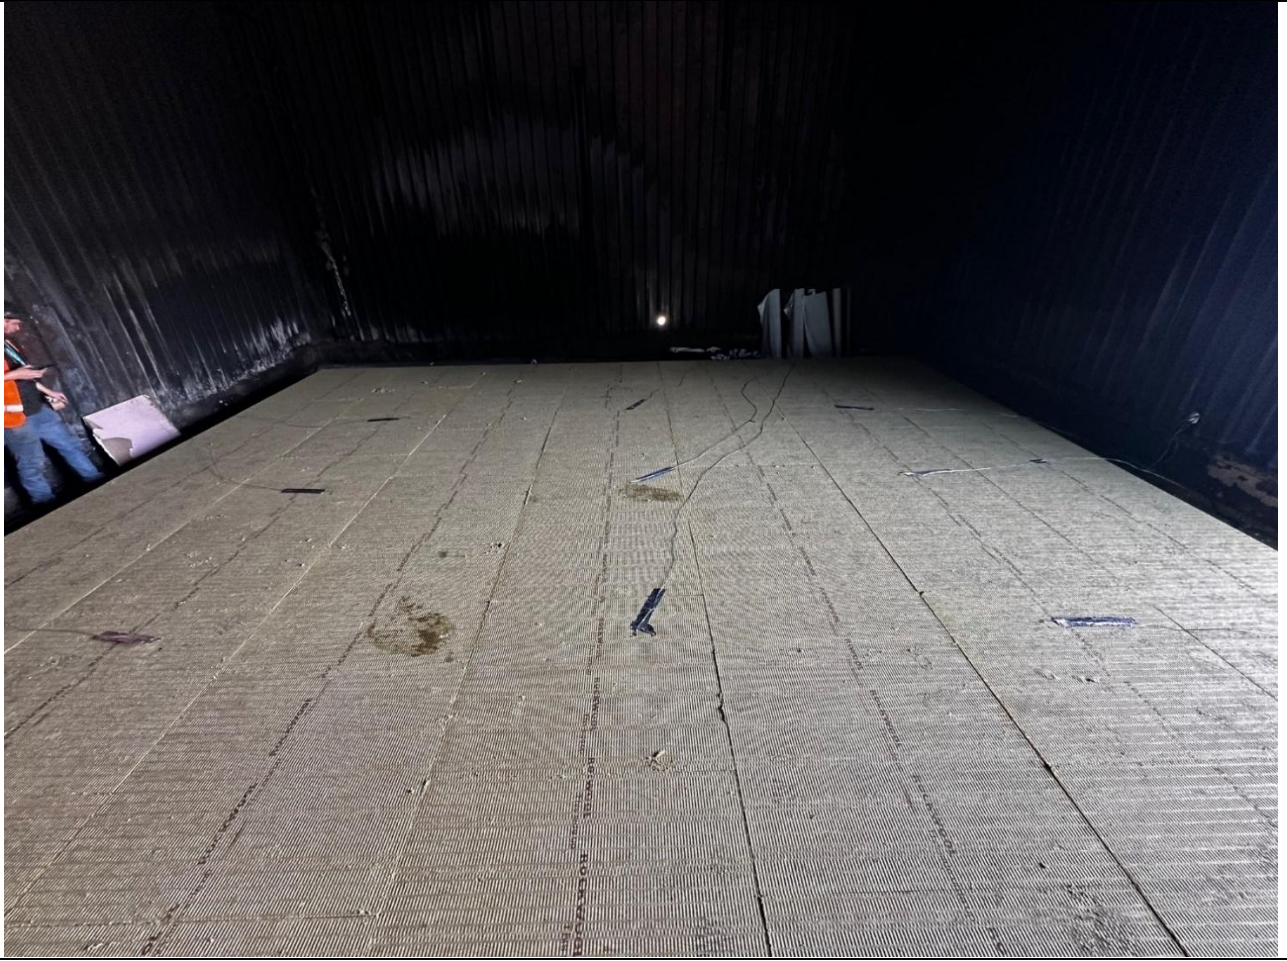
Figure 4: Stone wool insulation assembly and thermocouple layout.

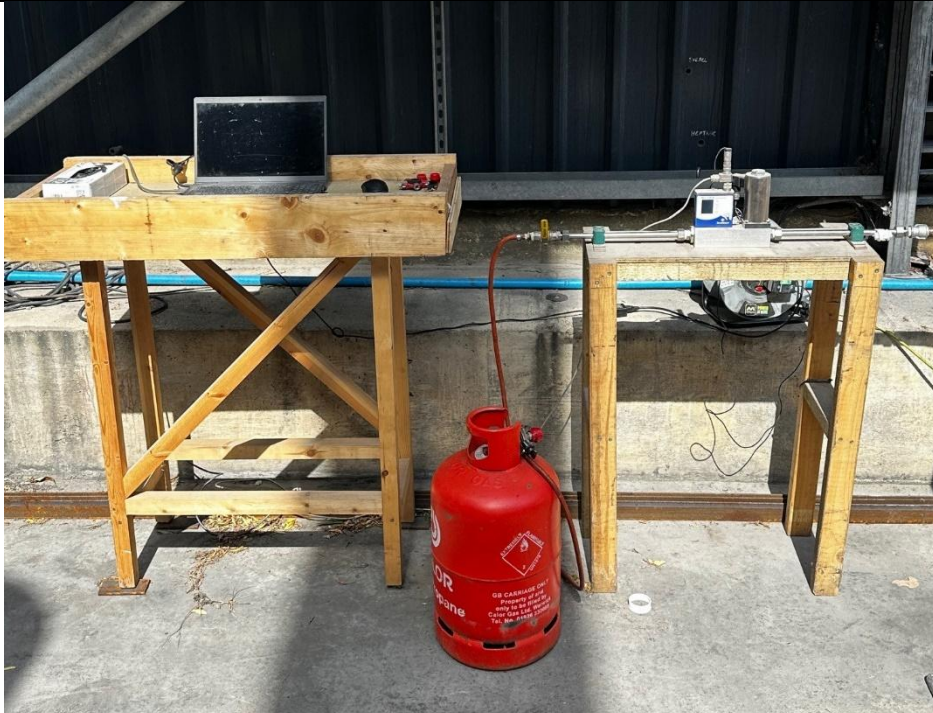
Figure 7: Mass flow controller set-up.

A mass flow controller was used to regulate the propane gas burner (See Figure 7). A datalogger was used to record all thermocouple readings throughout the tests.

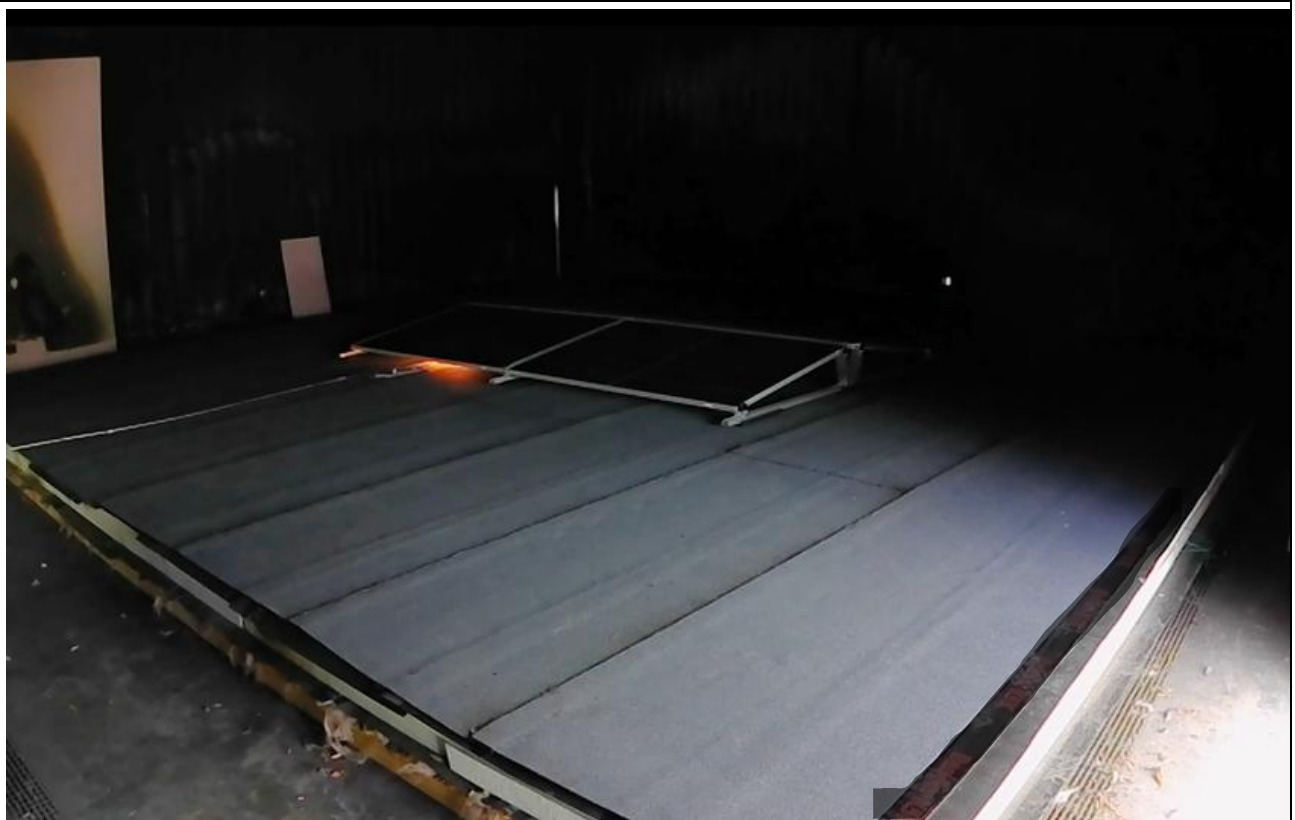
Figure 11: Video camera view front left corner of the roller shutter. (Camera 1)

- Camera 1 / Front left corner of the roller shutter
- Camera 2 / Back right corner of the roller shutter
- Camera 3 / Central to the solar panels

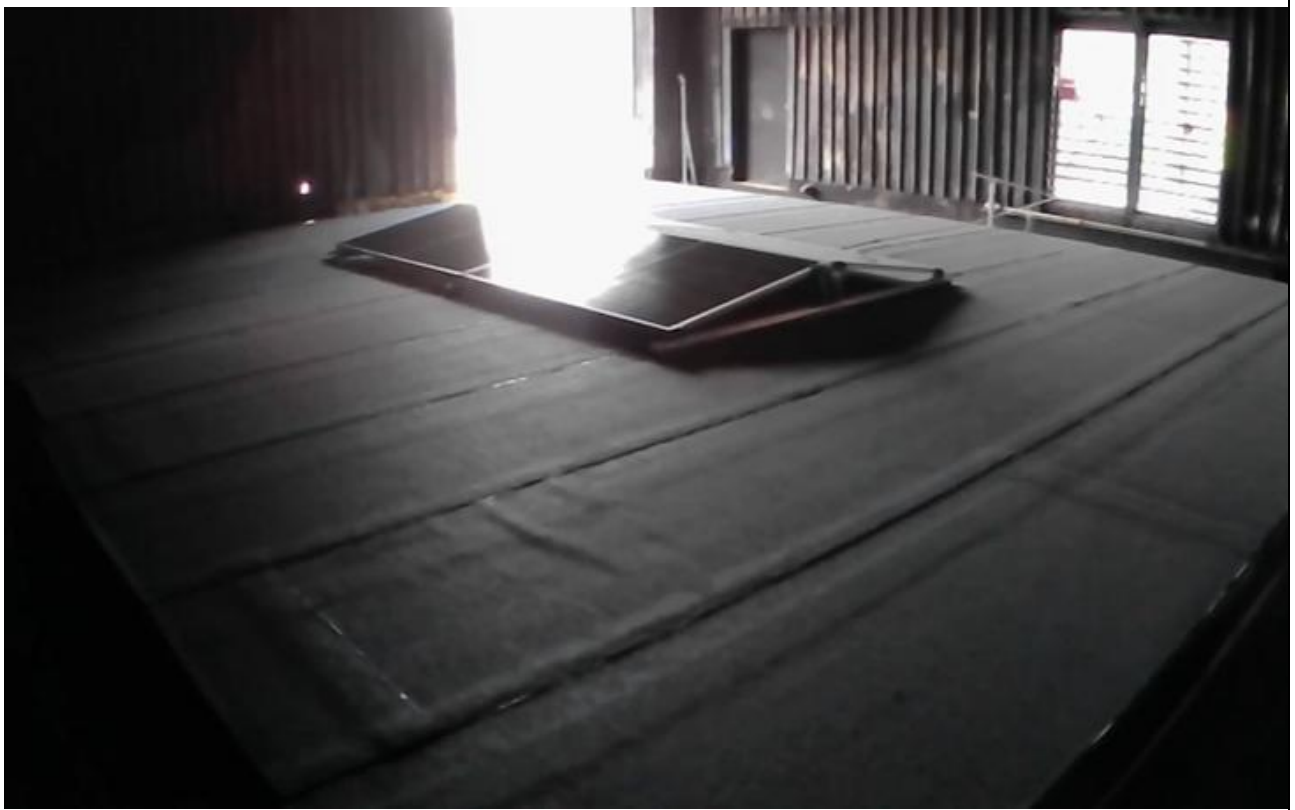
Figure 12: Video camera view back right corner of the roller shutter. (Camera 2)

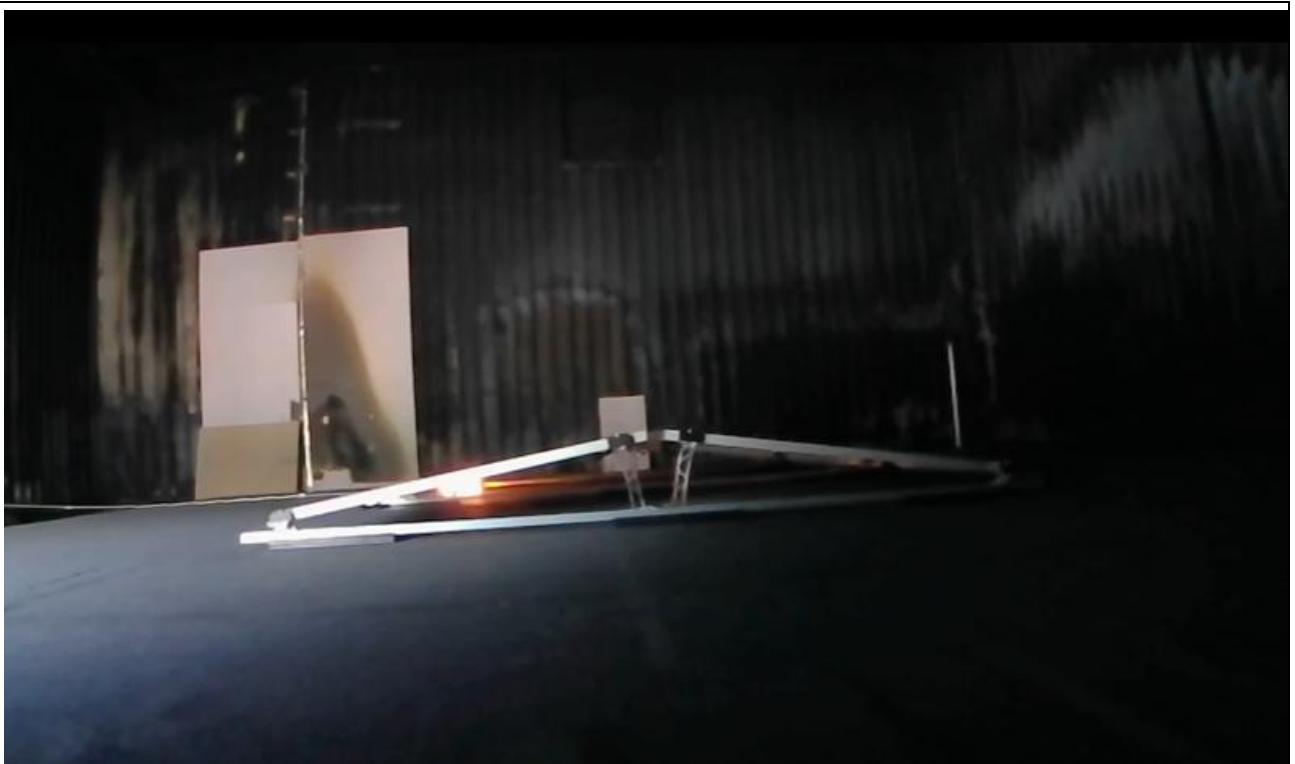
Figure 13: Video camera view central to the solar panels. (Camera 3)

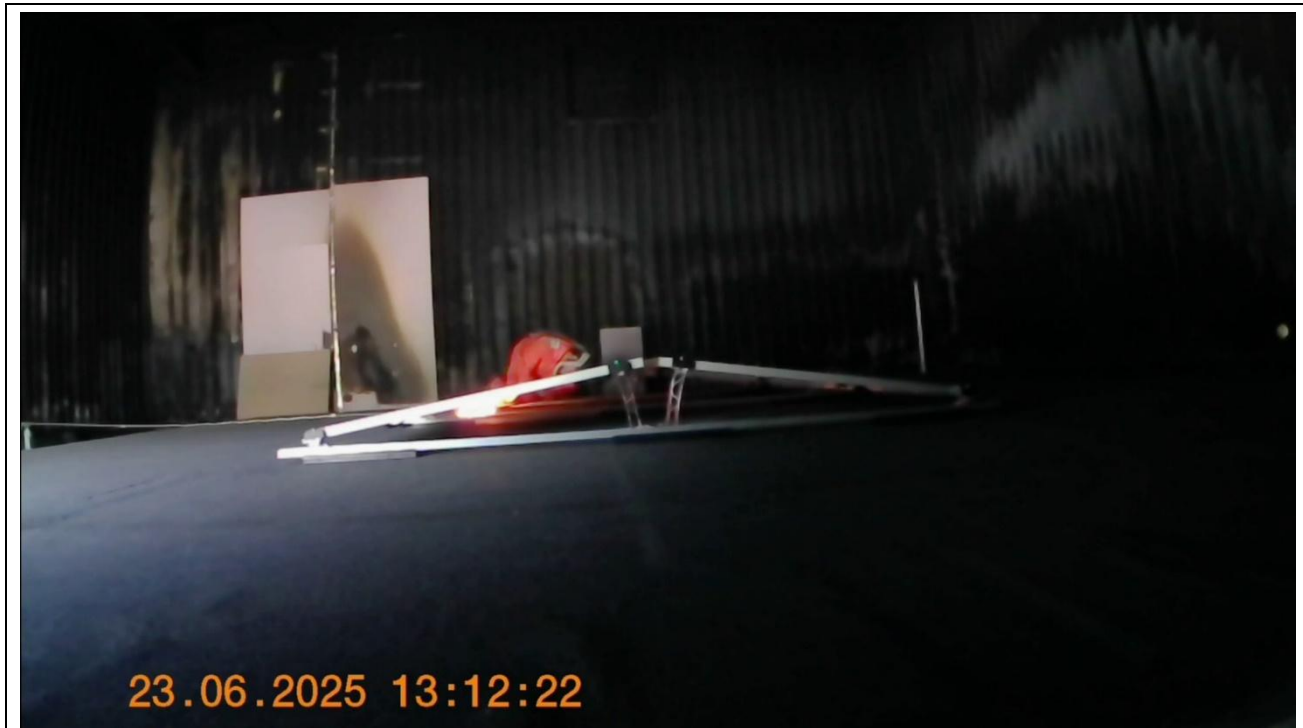
Figure 14: Ignition of gas burner (Camera 3)

| Time from ignition (mm:ss) | Visual observations |
|---|---|
| 00:00 | Ignition of gas burner |

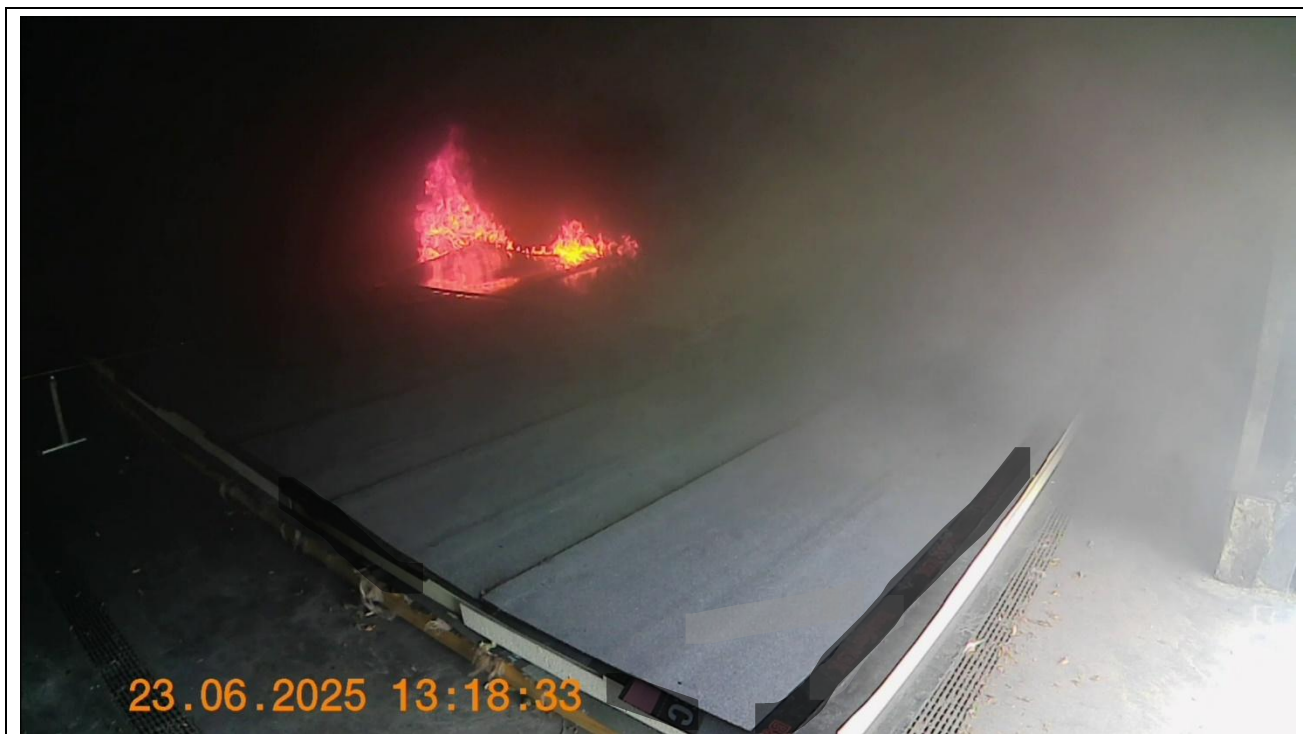
Figure 15: Solar panel above gas burner fully involved (Camera 1)

| Time from ignition (mm:ss) | Visual observations |
|---|---|
| +06:00 | Solar panel above gas burner fully involved |

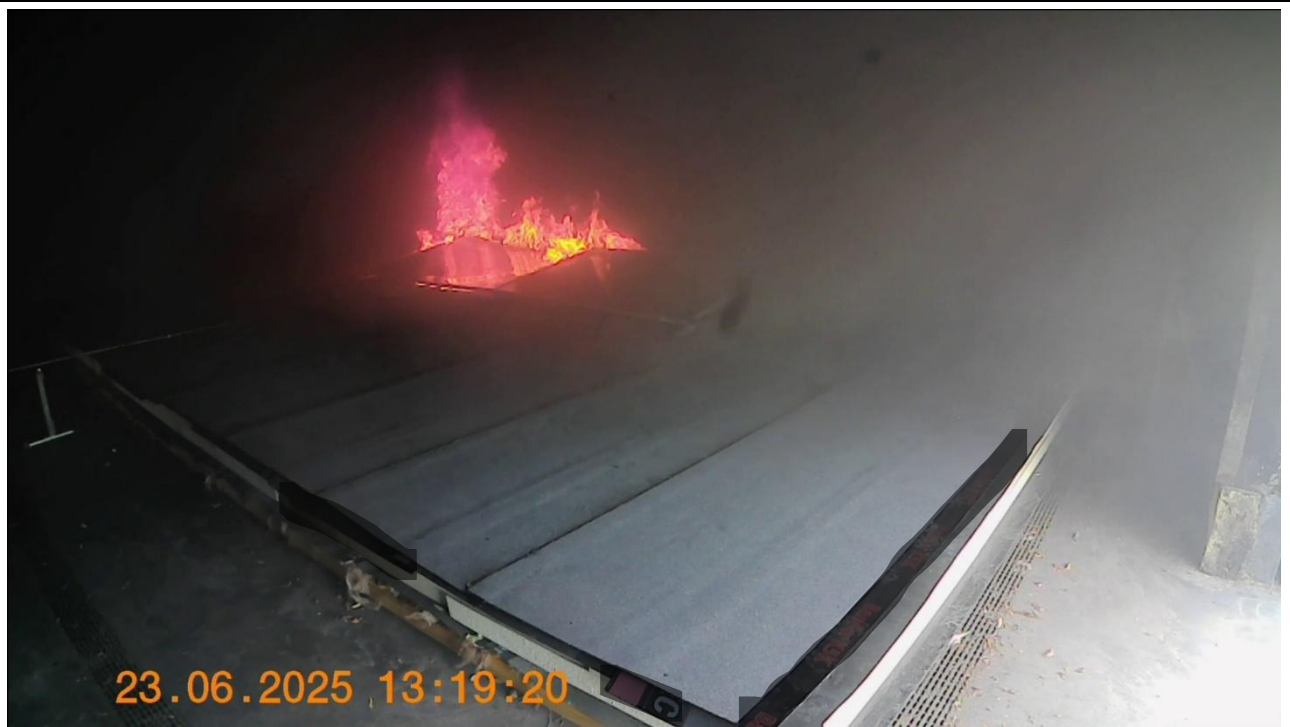
Figure 16: Solar panel opposite gas burner fully involved (Camera 1)

| Time from ignition (mm:ss) | Visual observations |
|---|---|
| +07:00 | Solar panel opposite gas burner fully involved |

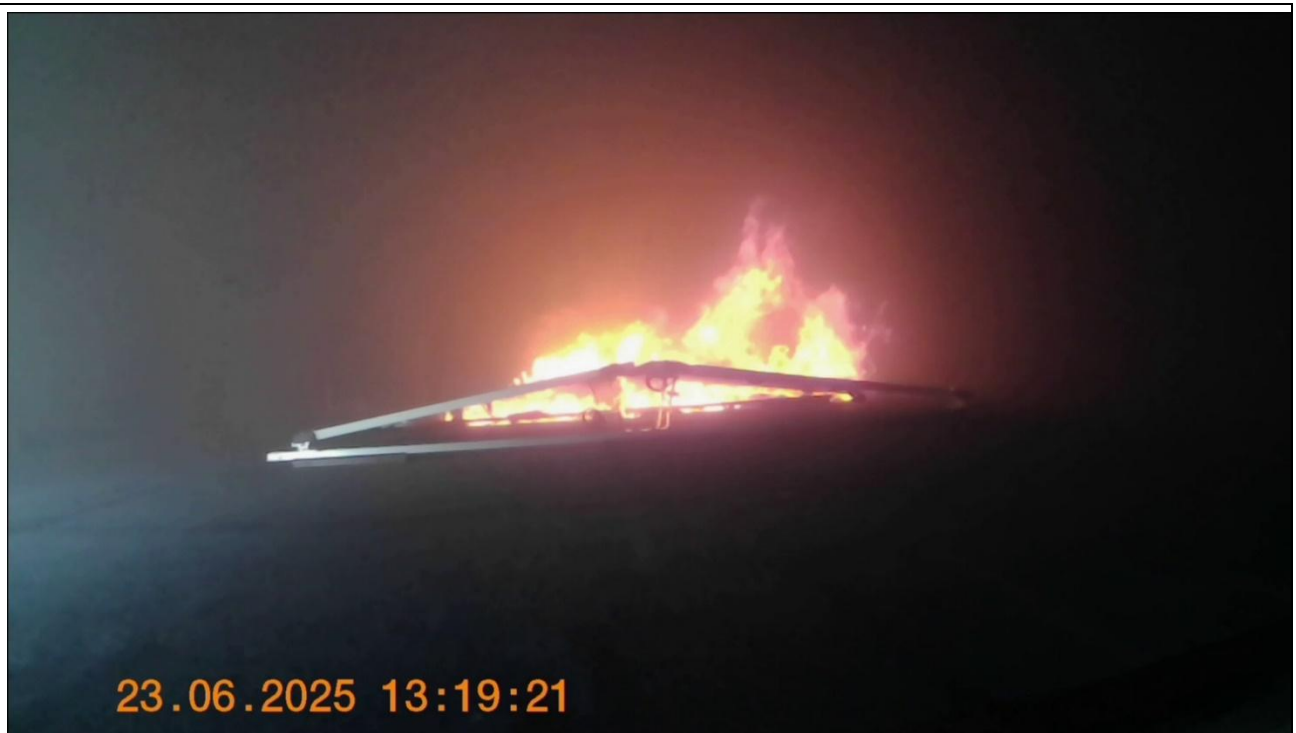
Figure 17: Roof assembly begins to catch alight (Camera 3)

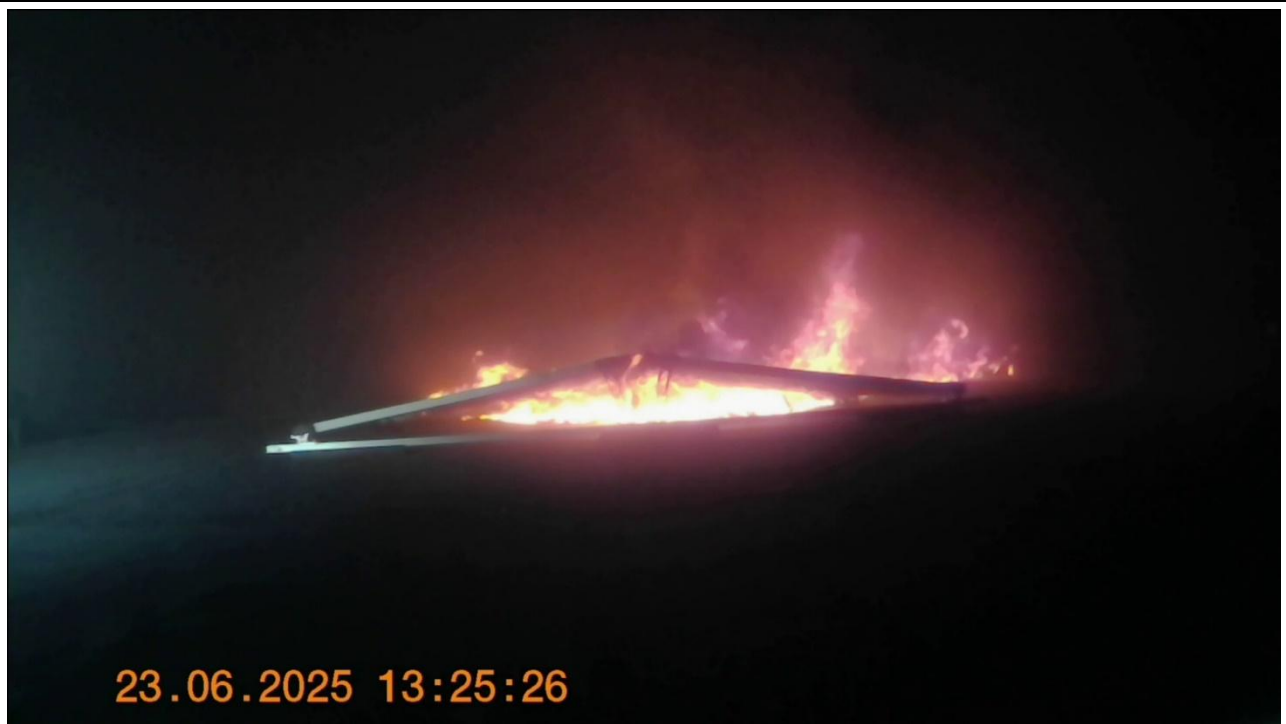
Figure 18: Fire begins to spread across roof assembly (Camera 3)

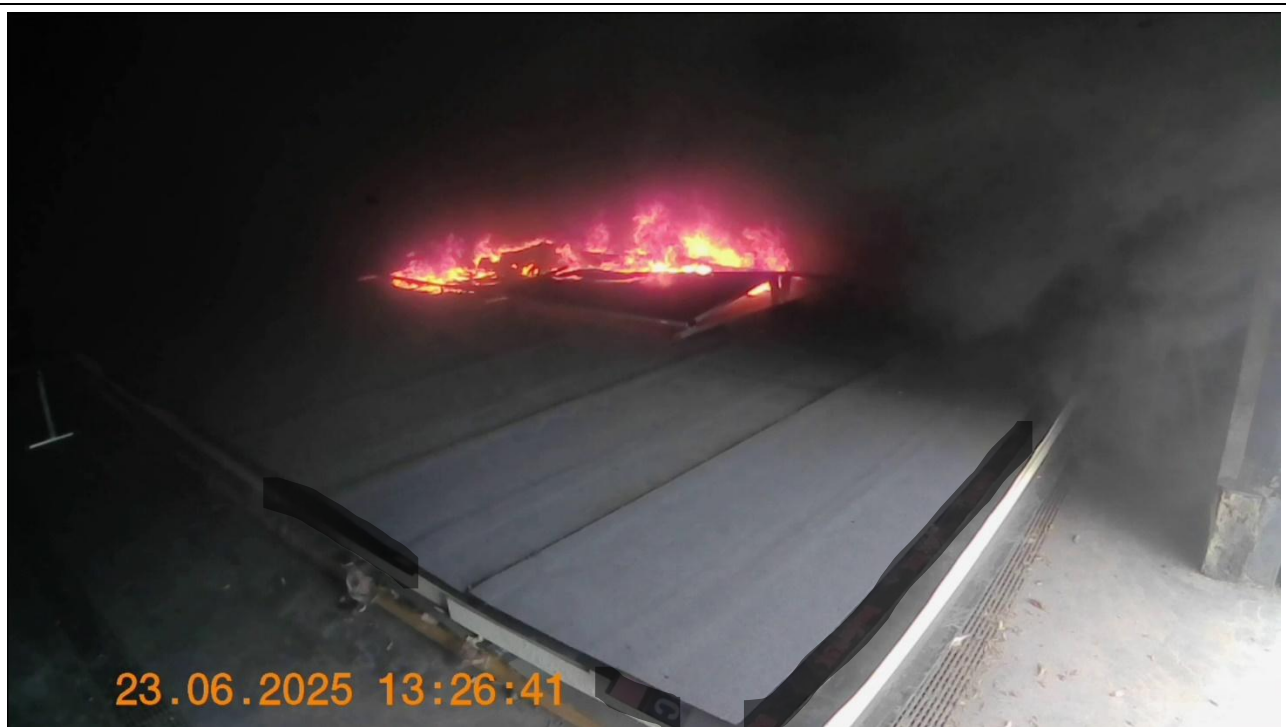
Figure 19: Solar panel diagonally across from gas burner fully involved (Camera 1)

| Time from ignition (mm:ss) | Visual observations |
|---|---|
| +14:00 | Solar panel diagonally across from gas burner fully involved |

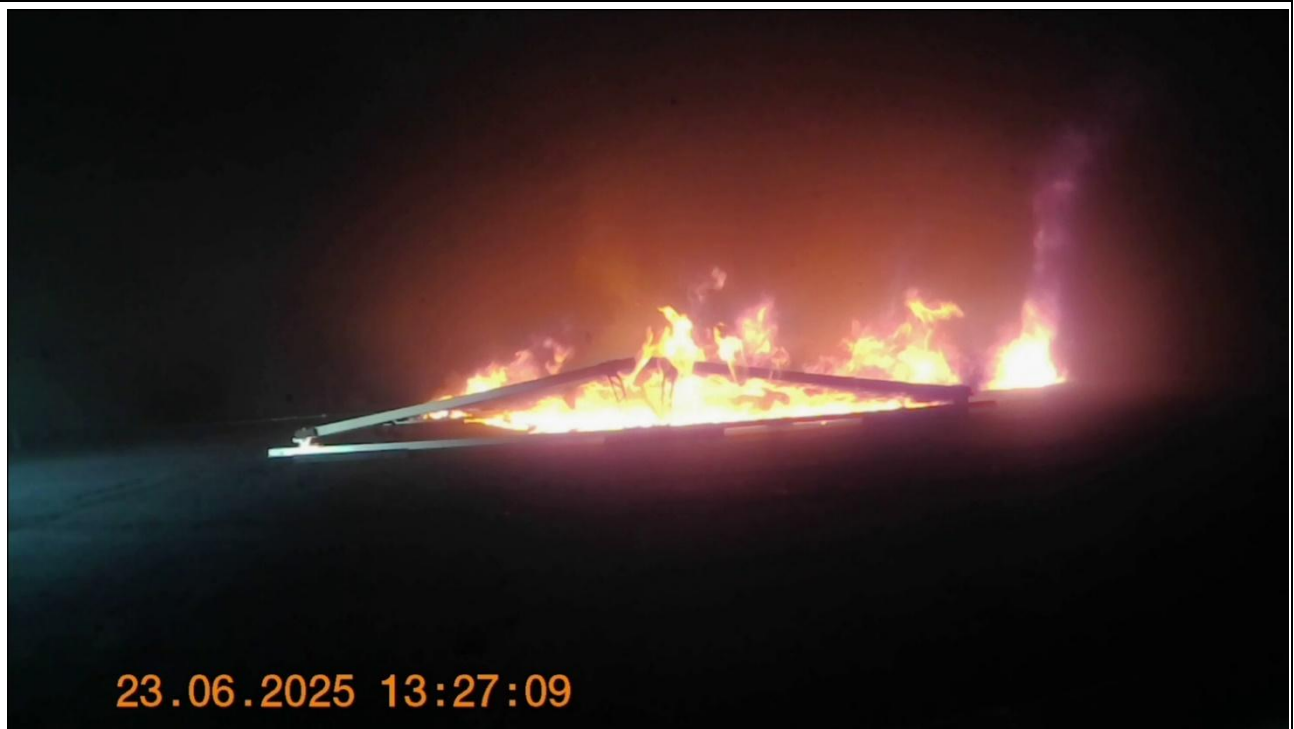
Figure 20: Solar panel next to gas burner begins to catch alight (Camera 3)

| Time from ignition (mm:ss) | Visual observations |
|---|---|
| +15:00 | Solar panel next to gas burner begins to catch alight |

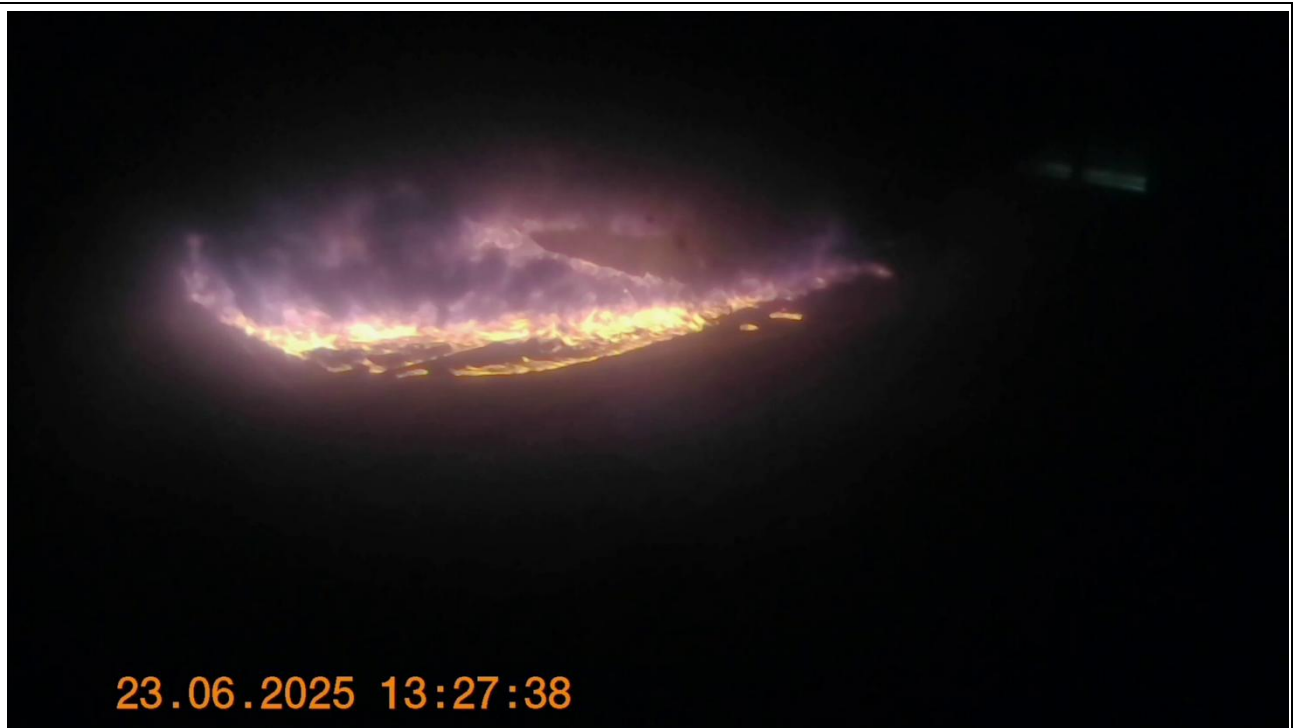
Figure 21: Fire continues to spread across roof assembly (Camera 2)

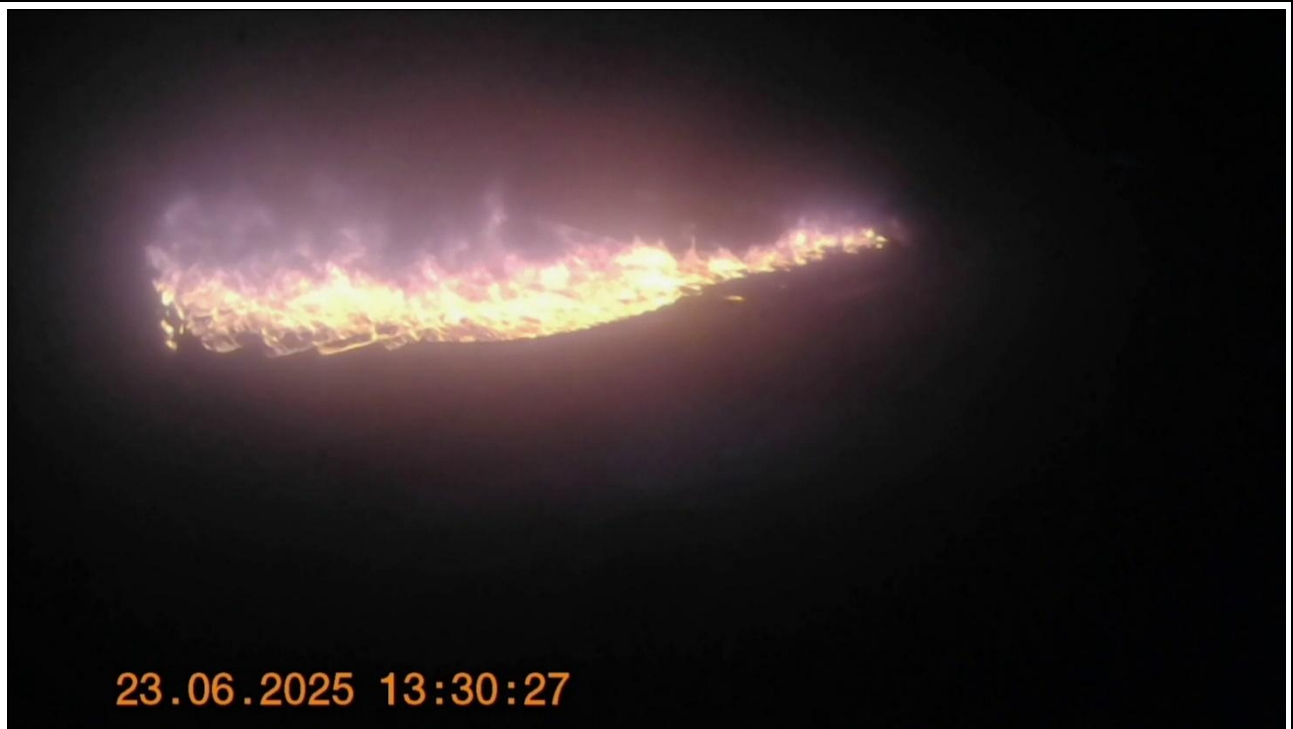
Figure 22: Fire exhibits further spread across roof assembly (Camera 2)

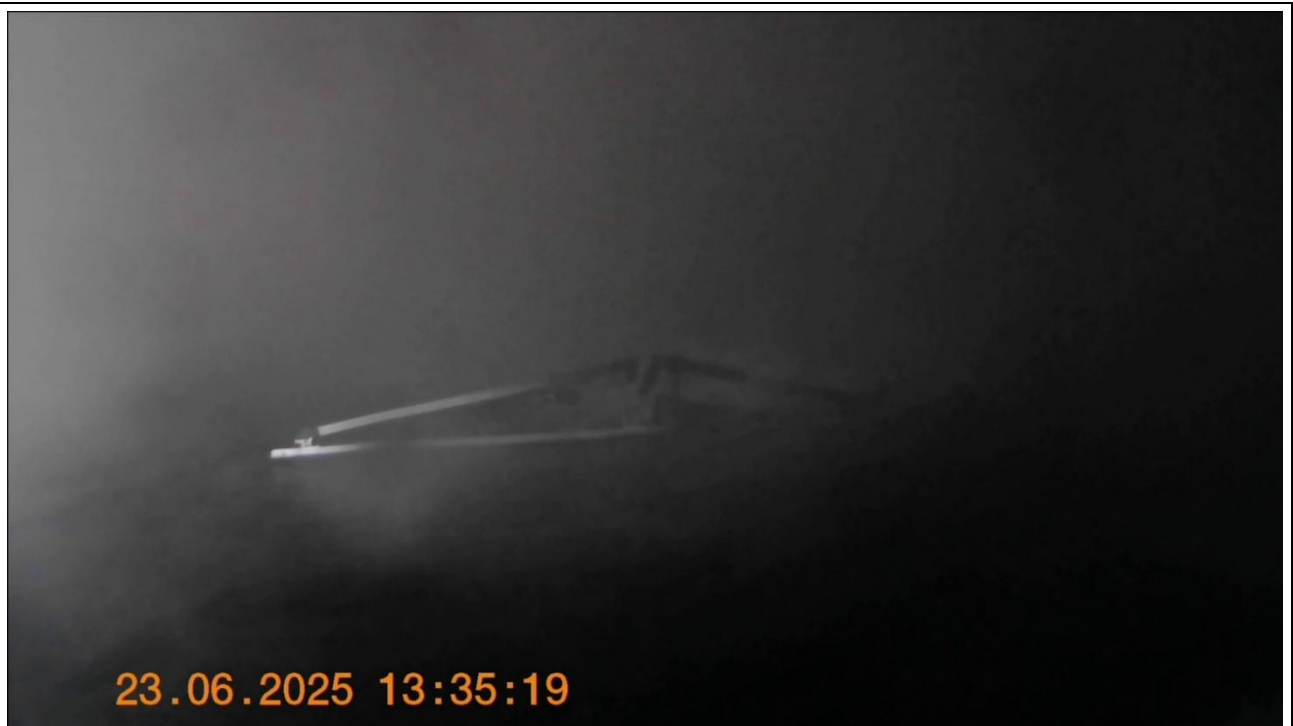
Figure 23: Test fully extinguished (Camera 3)

| Time from ignition (mm:ss) | Visual observations |
|---|---|
| +23:00 | Test fully extinguished |

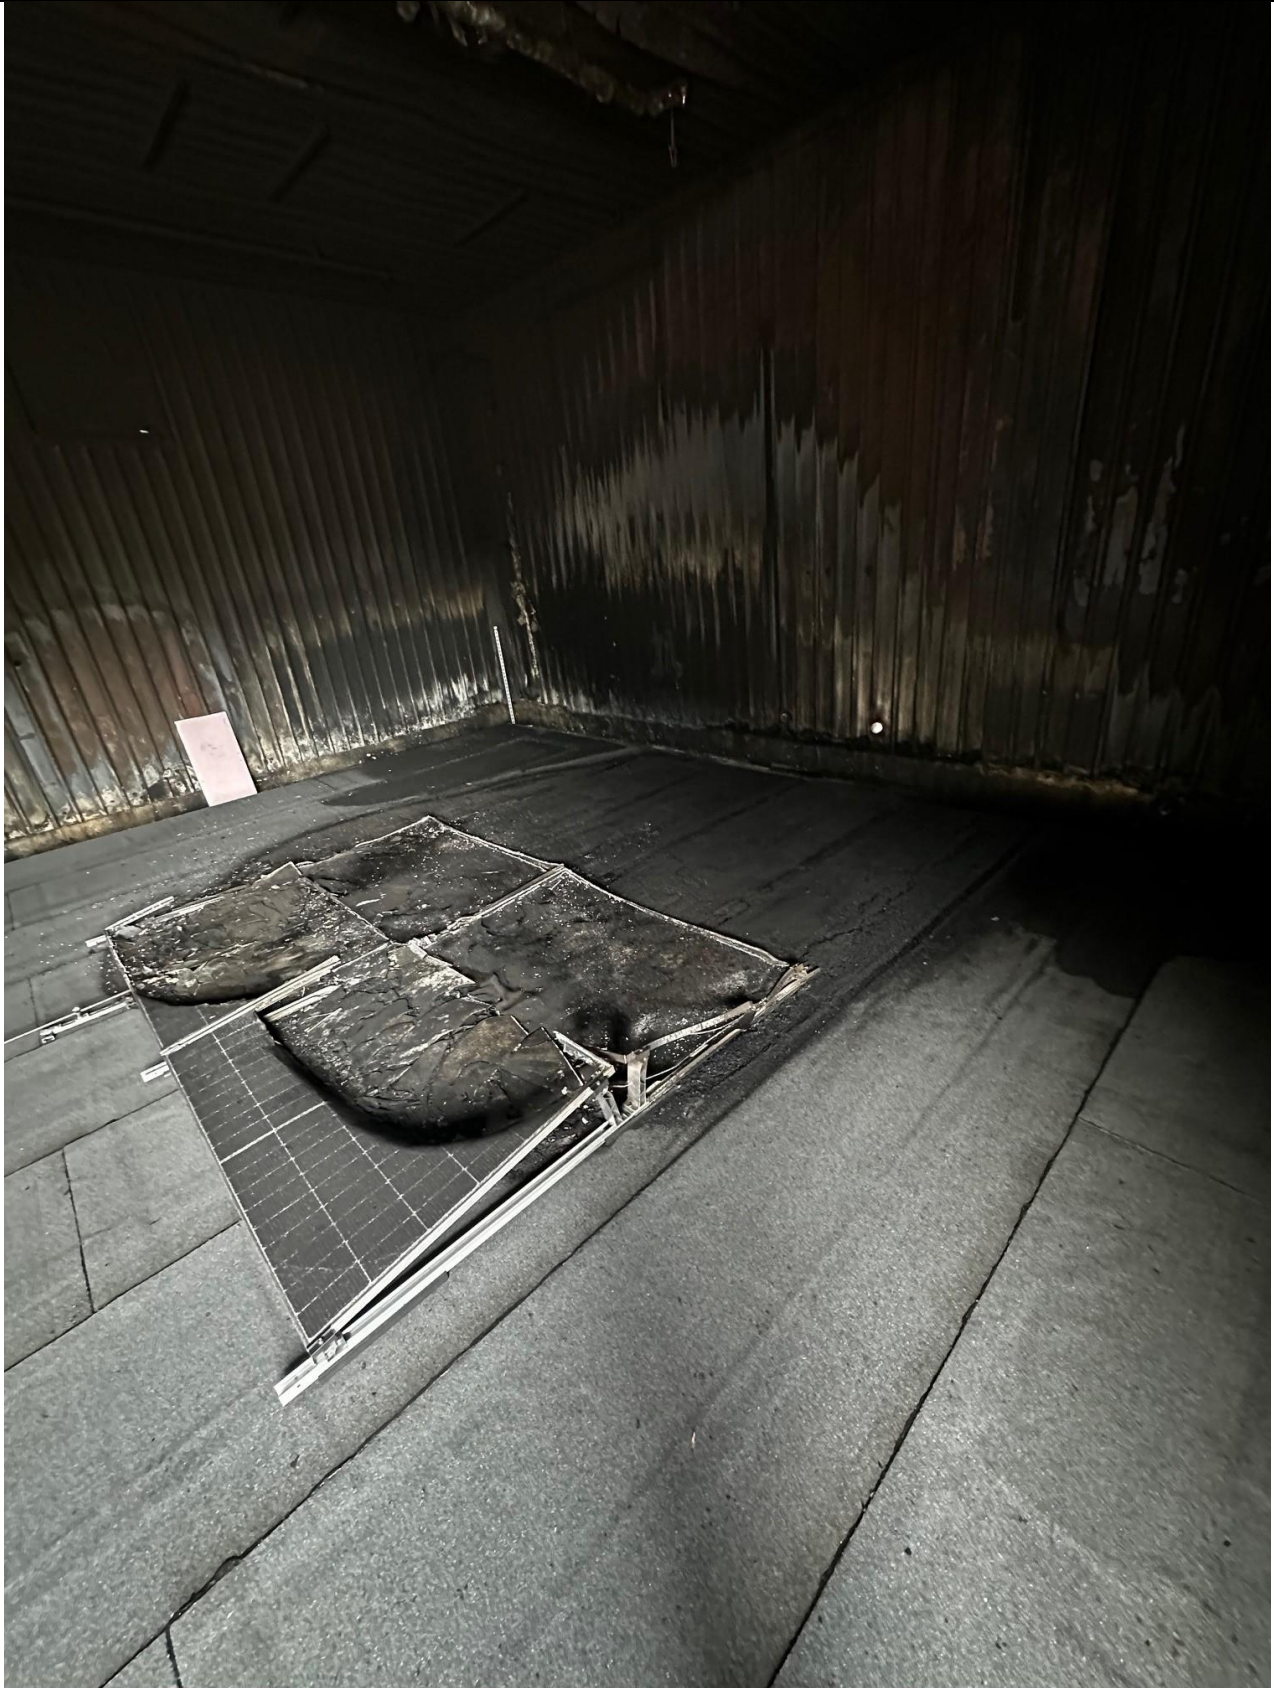
Figure 25: Damage of PV panels and roofing membrane after test with PIR insulated roof.

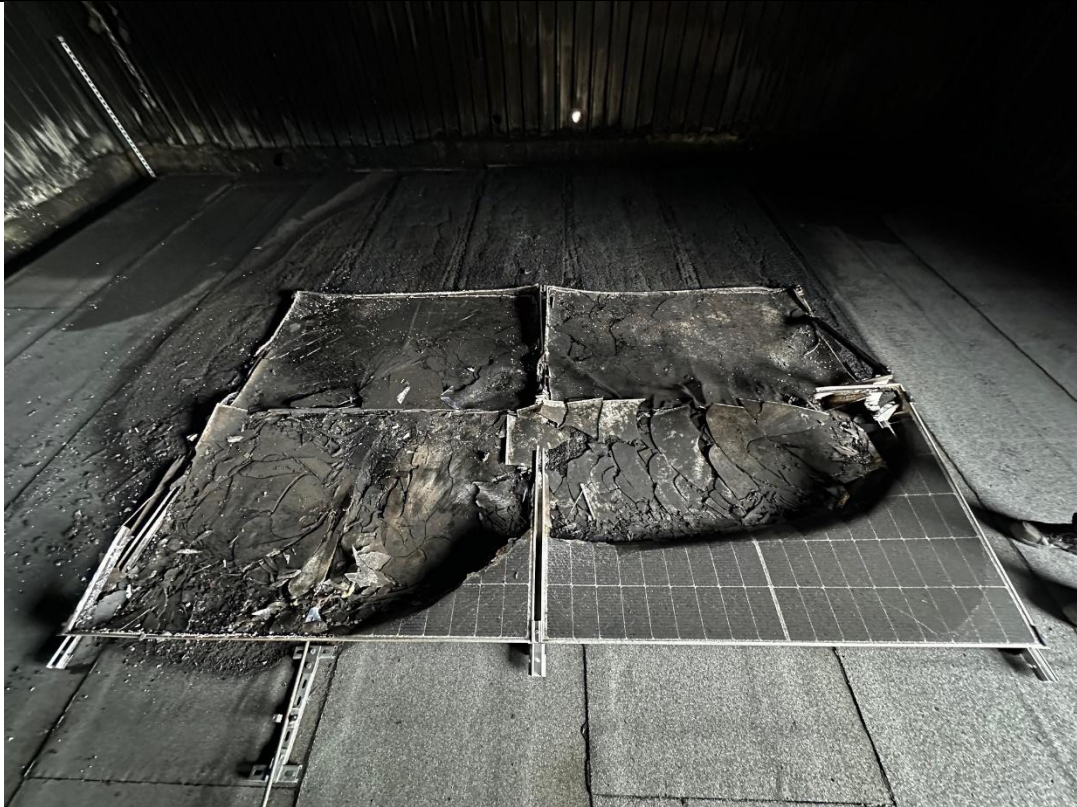
Figure 26: Damage of PV panels after test with PIR insulation roof.

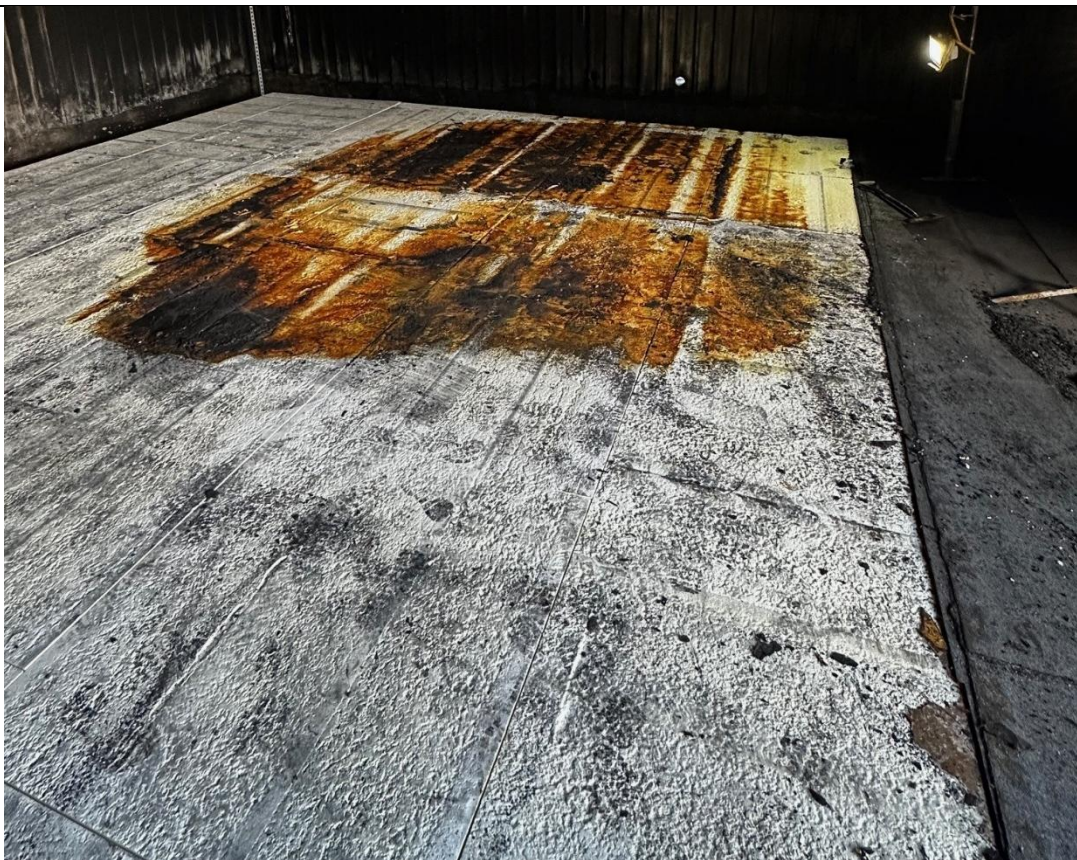
Figure 27: PIR insulation Post-test.
