# FIRE RESEARCH AND TESTING REPORT

REFERENCE NUMBER: FPA/ 107586

This research was to assess the fire performance and behaviour of two different insulation products within a flat roof assembly with reinforced bituminous roofing membranes while being exposed to a PV solar panel fire.

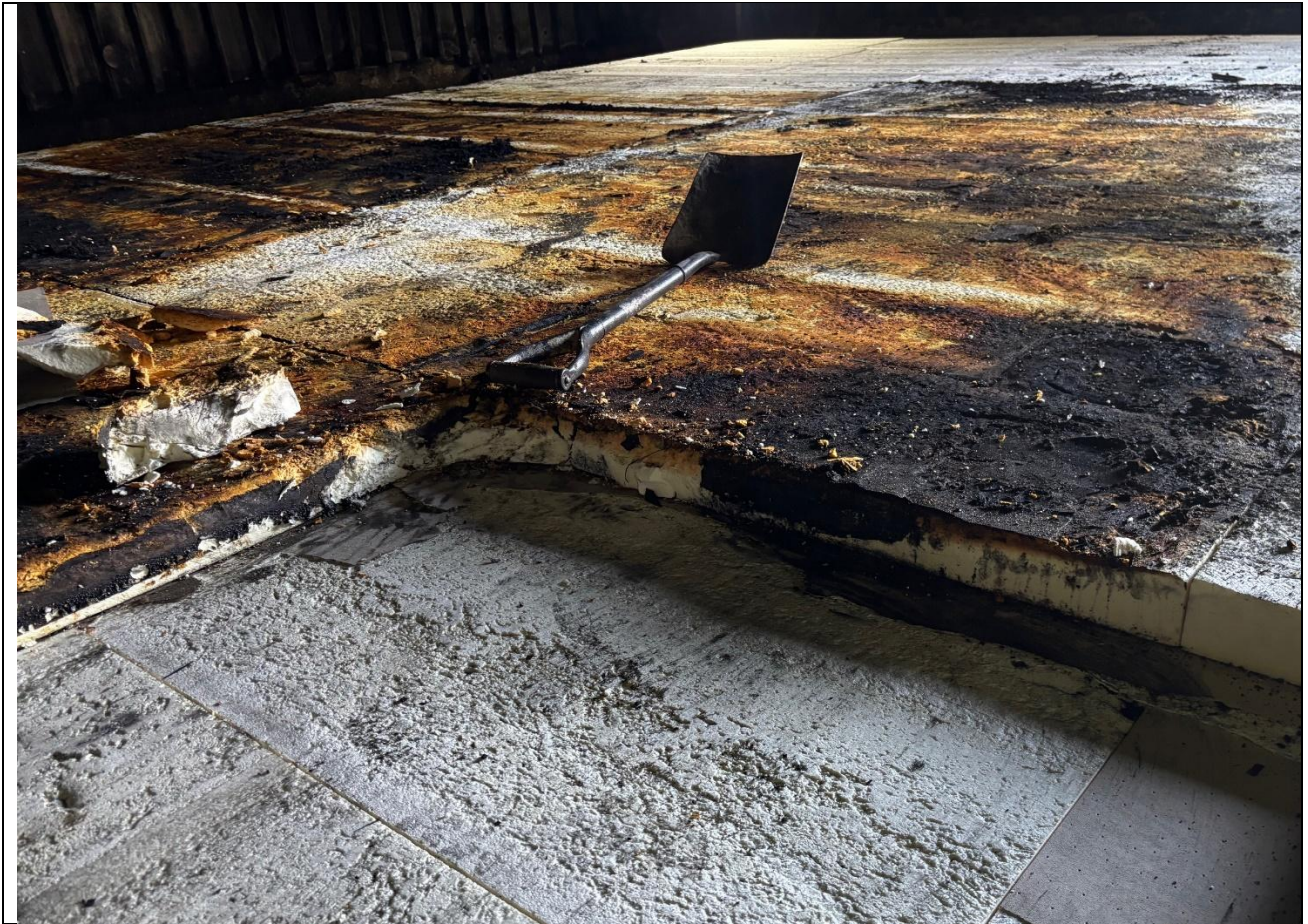
Figure 28: Charring depth within the PIR insulation Post-test

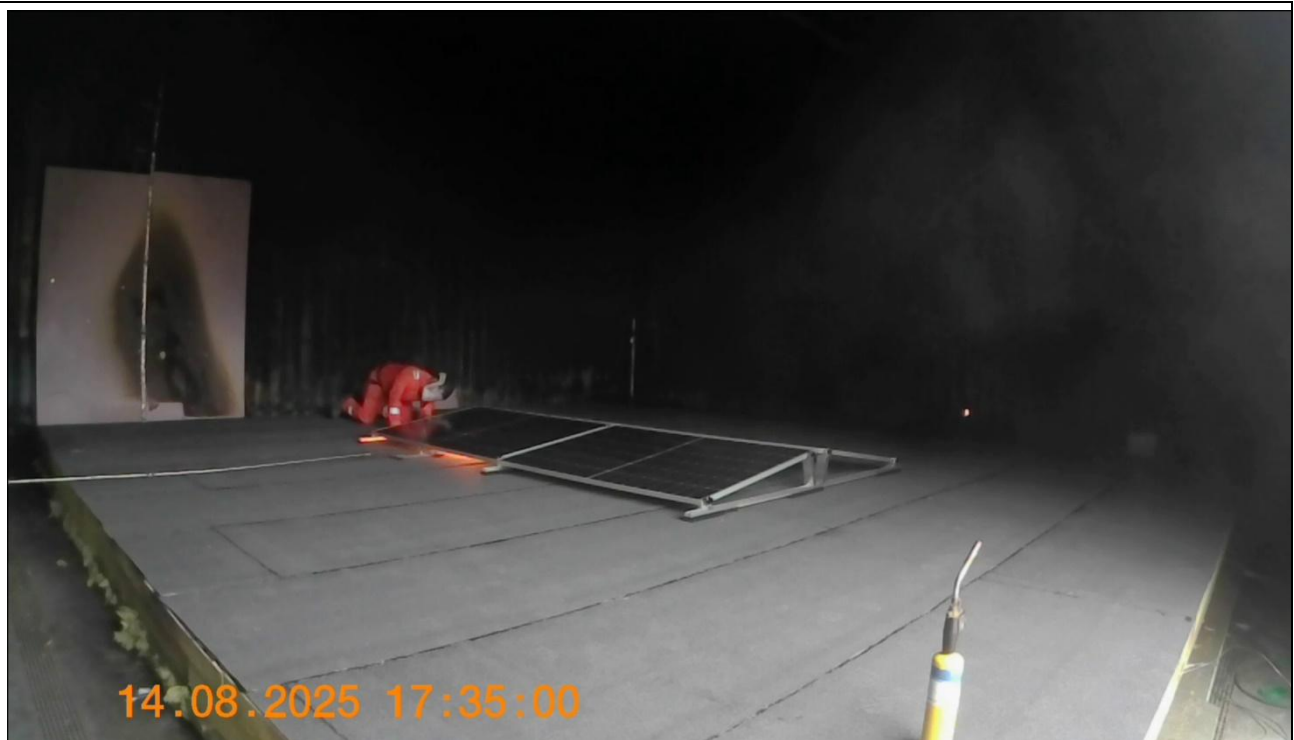
Figure 36: Ignition of gas burner (Camera 1)

| Time from ignition (mm:ss) | Visual observations |
|---|---|
| 00:00 | Ignition of gas burner |

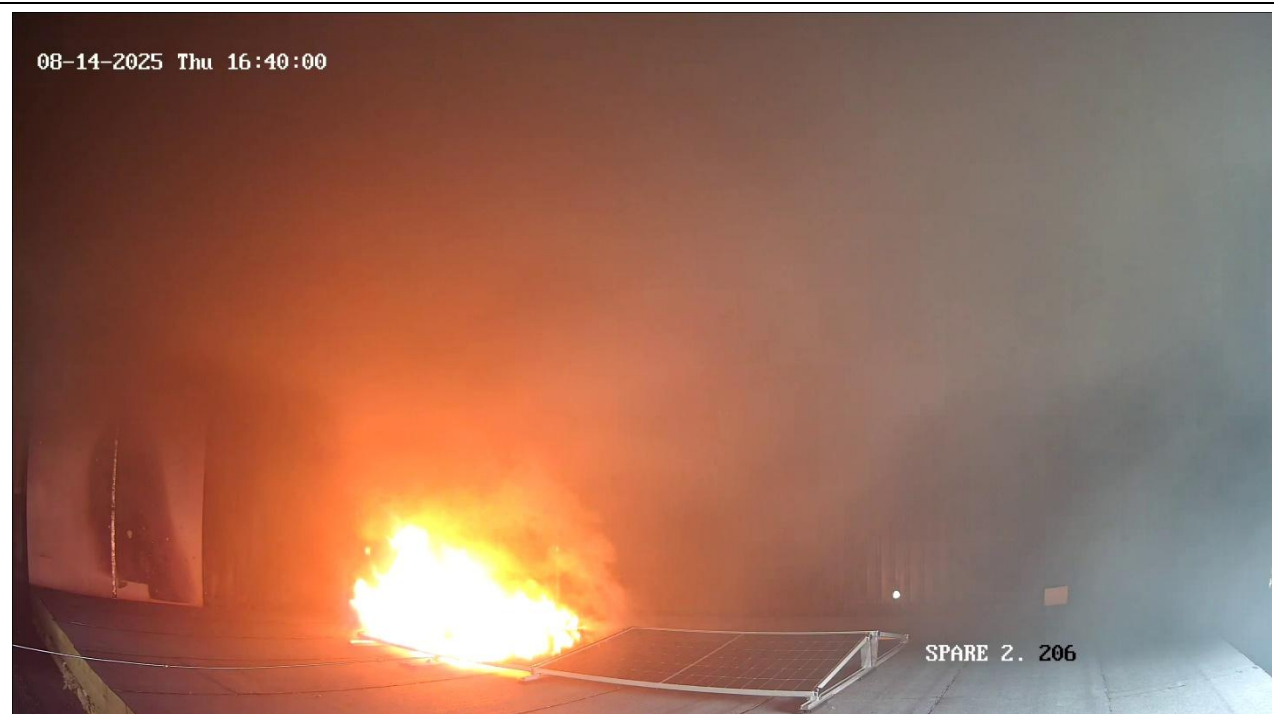
Figure 37: Solar panel above gas burner fully involved (CCTV)

| Time from ignition (mm:ss) | Visual observations |
|---|---|
| +05:00 | Solar panel above gas burner fully involved |

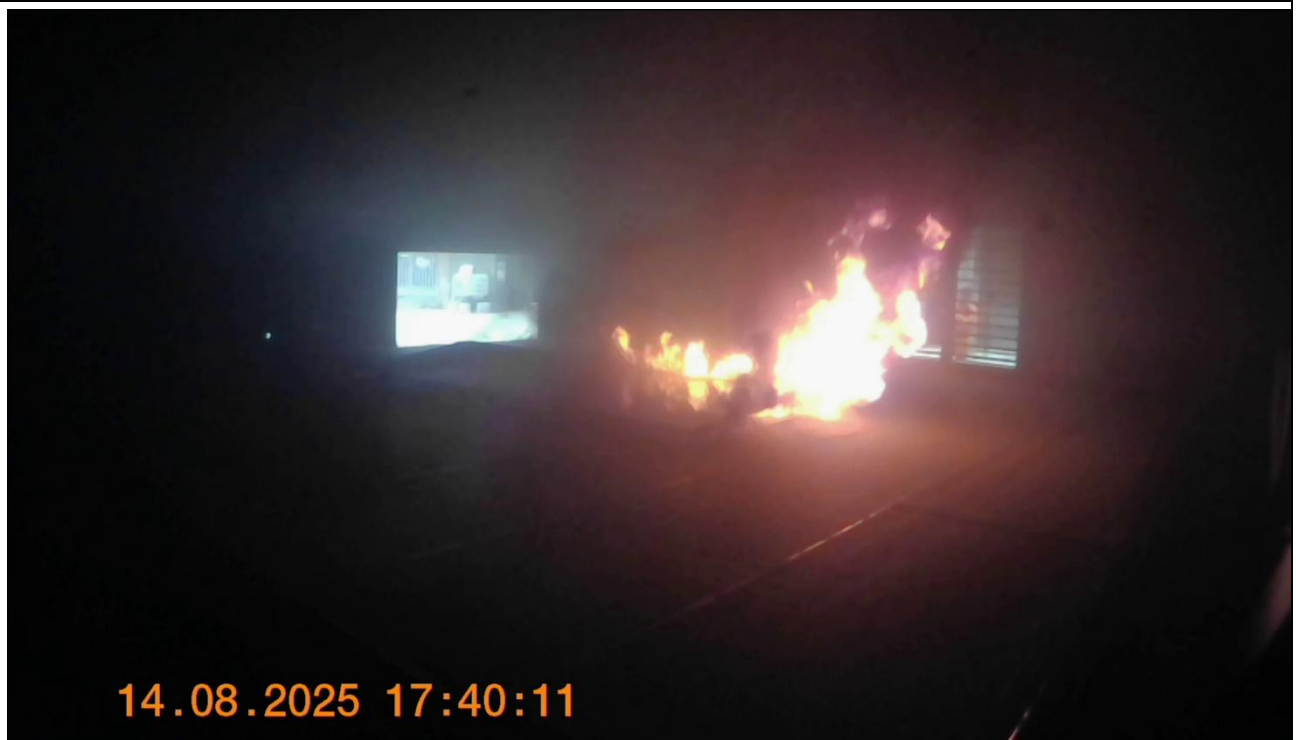
Figure 38: Roof assembly begins to catch alight (Camera 2)

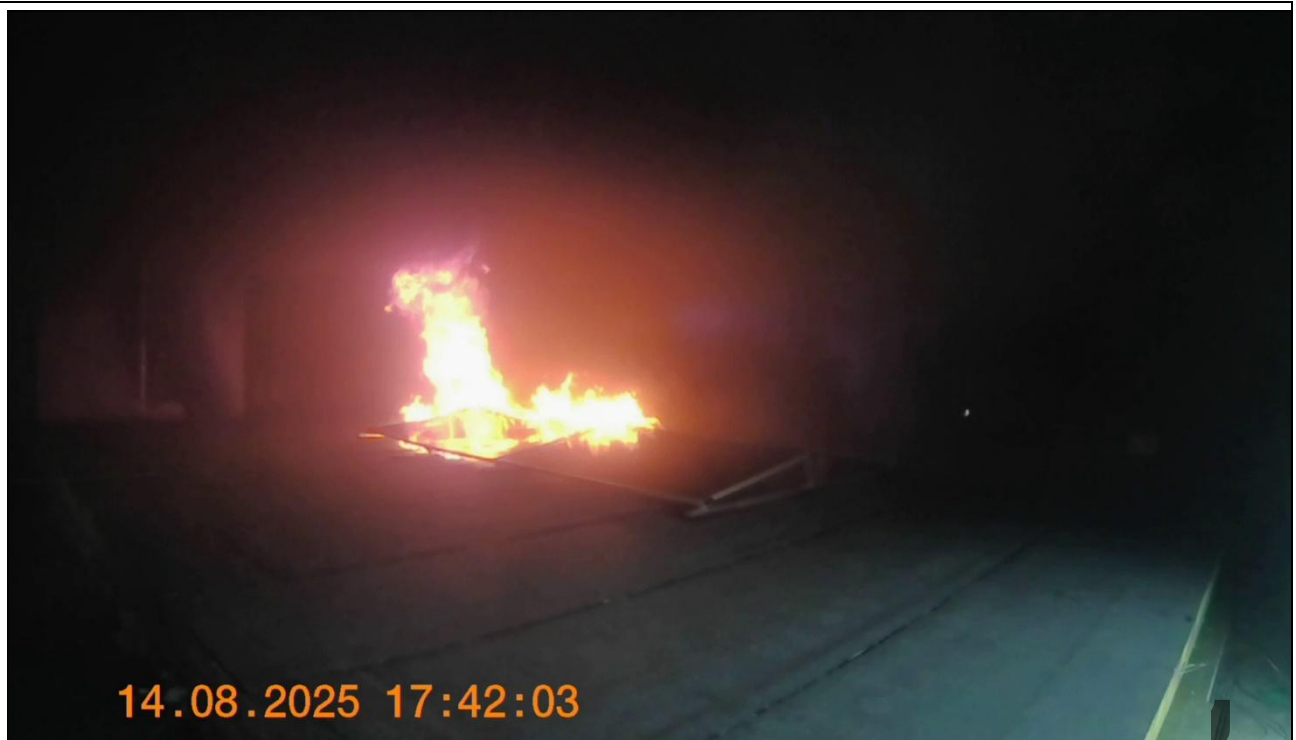
Figure 39: Solar panel opposite gas burner begins to catch alight (Camera 1)

| Time from ignition (mm:ss) | Visual observations |
|---|---|
| +07:00 | Solar panel opposite gas burner begins to catch alight |

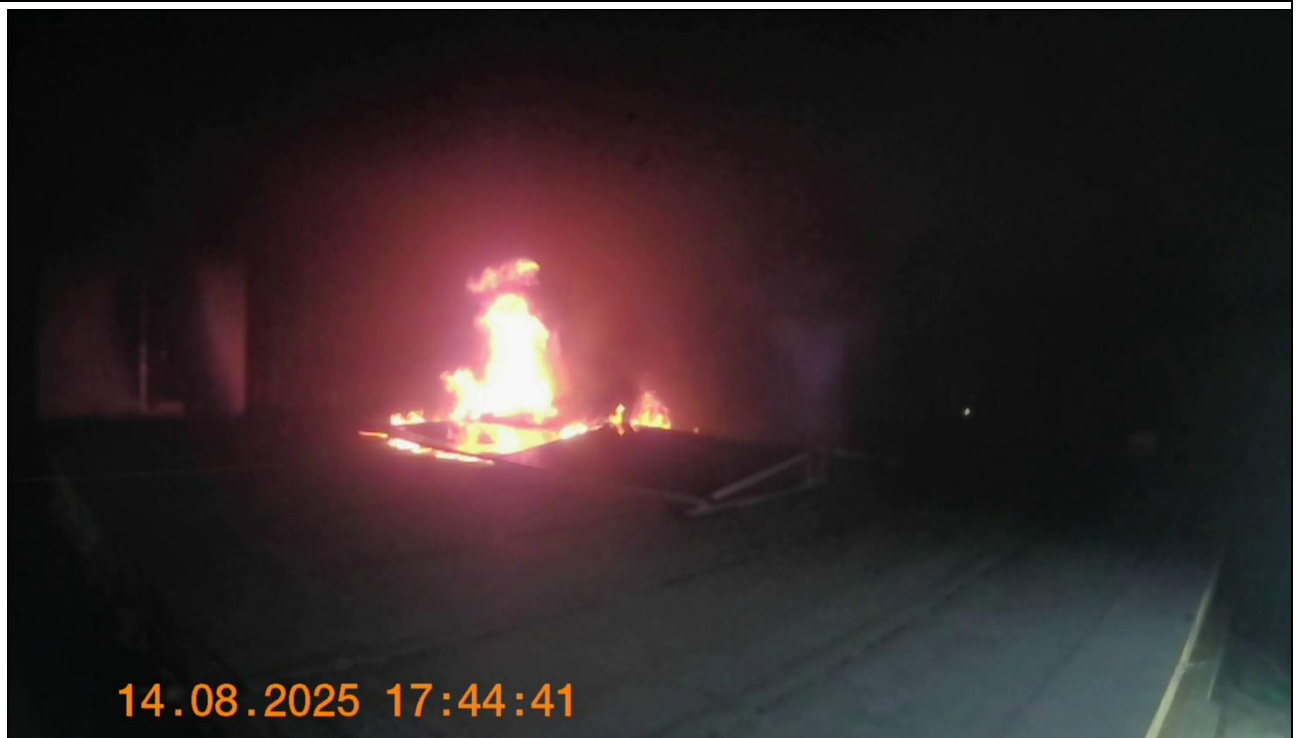
Figure 40: Solar panel opposite gas burner fully involved (Camera 1)

| Time from ignition (mm:ss) | Visual observations |
|---|---|
| +09:40 | Solar panel opposite gas burner fully involved |

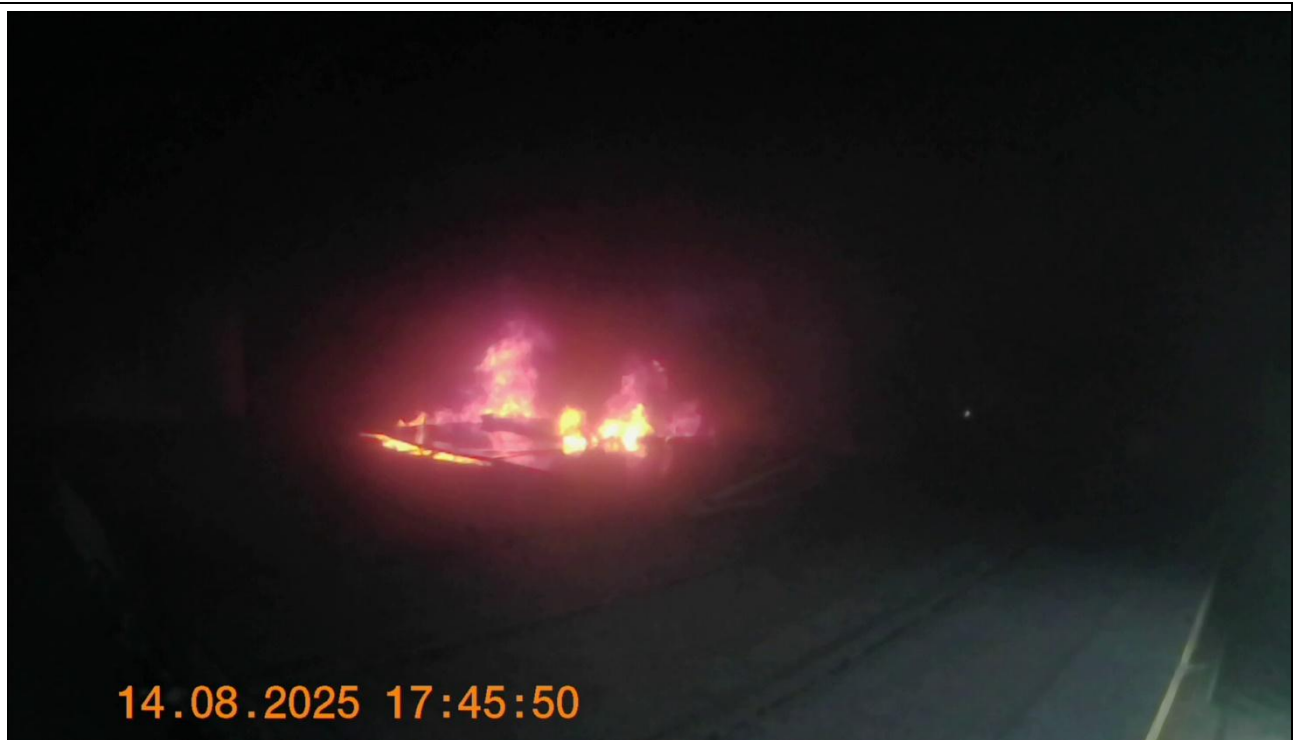
Figure 42: Solar panel next to gas burner begins to catch alight (Camera 1)

| Time from ignition (mm:ss) | Visual observations |
|---|---|
| +10:50 | Solar panel next to gas burner begins to catch alight |

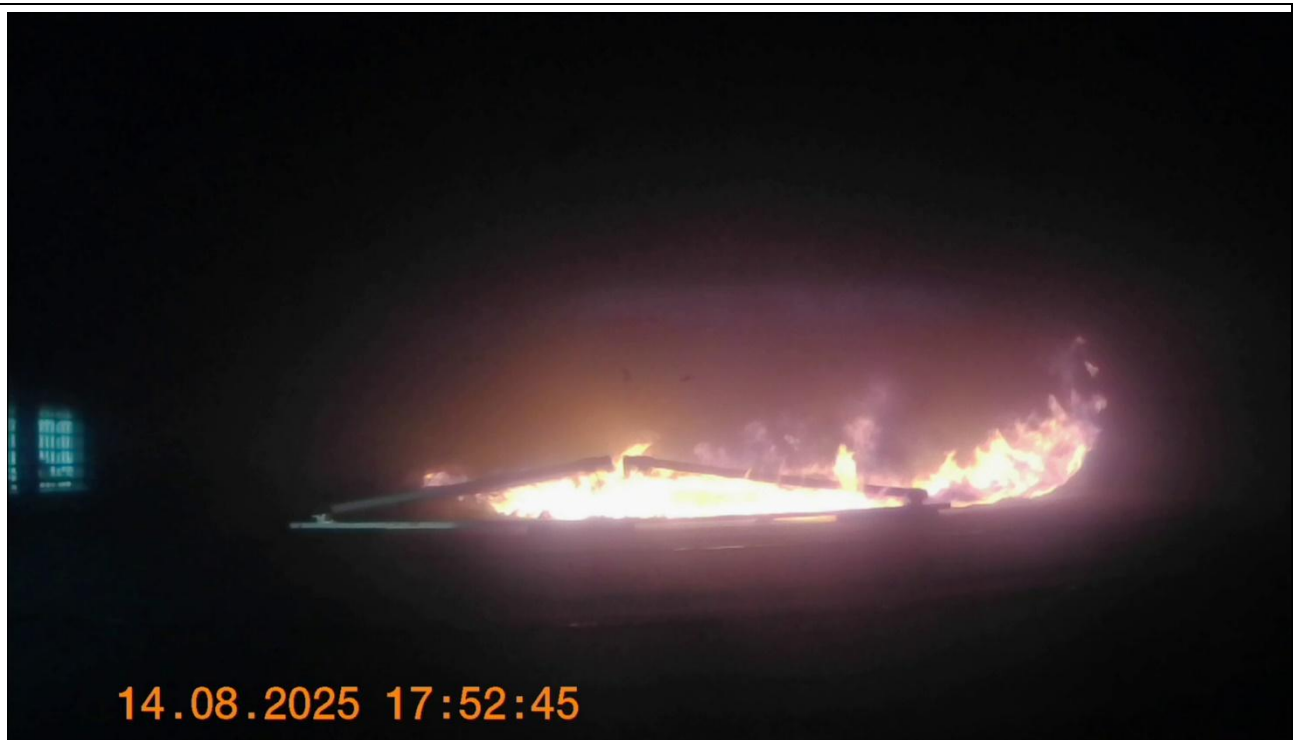
Figure 43: Fire continues to spread across roof assembly (Camera 3)

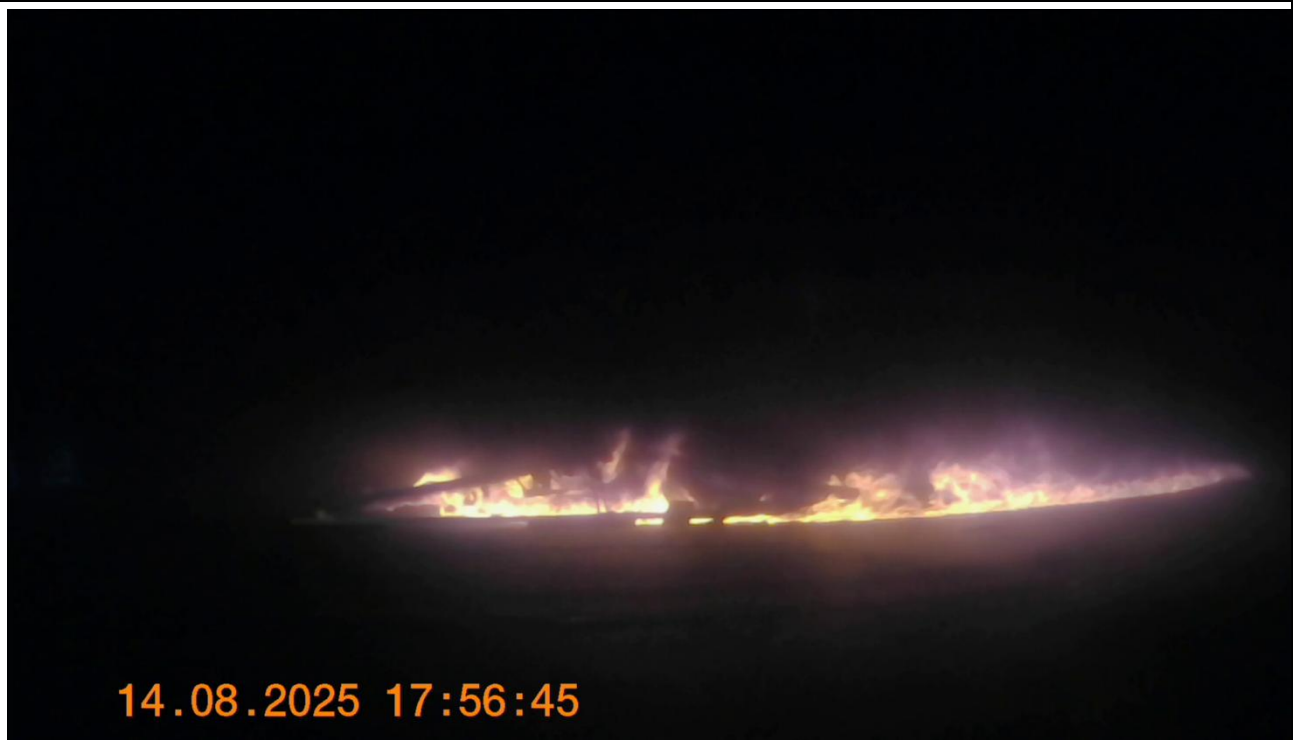
Figure 44: Fire exhibits further spread across roof assembly (Camera 3)

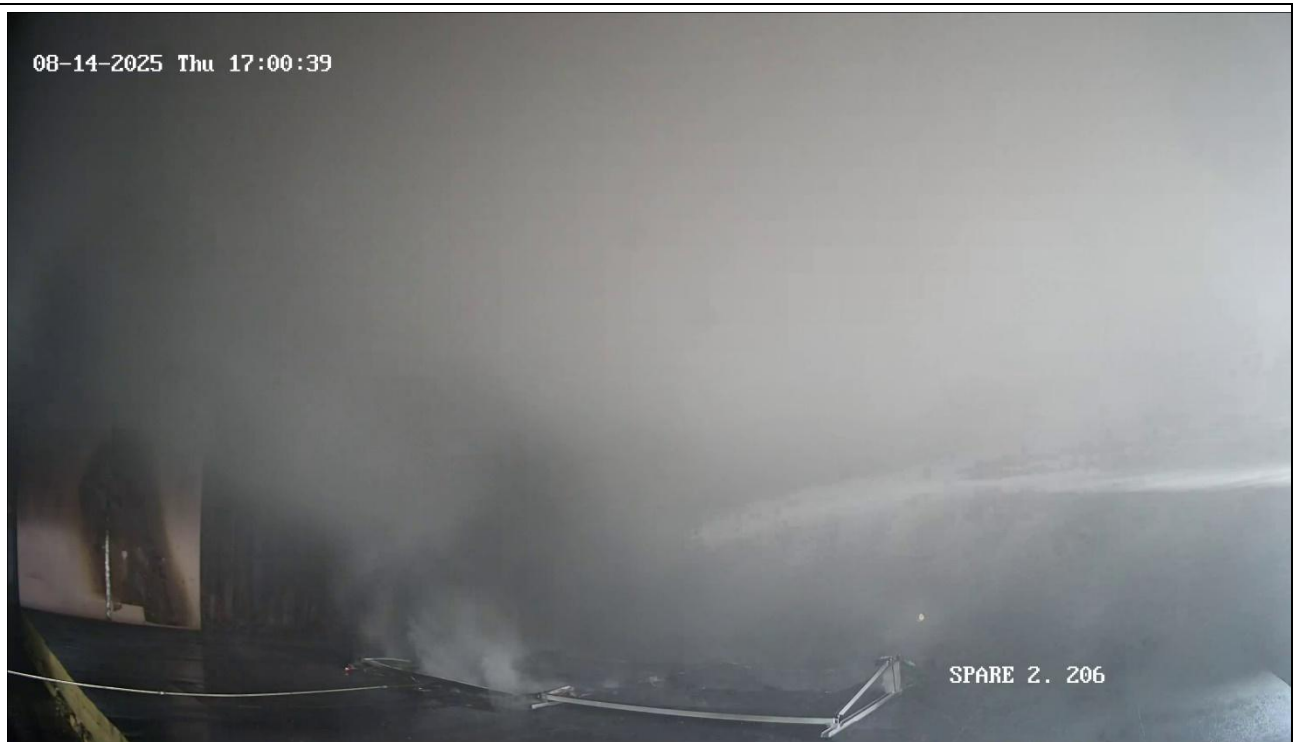
Figure 45: Test fully extinguished (CCTV)

| Time from ignition (mm:ss) | Visual observations |
|---|---|
| +25:40 | Test fully extinguished |

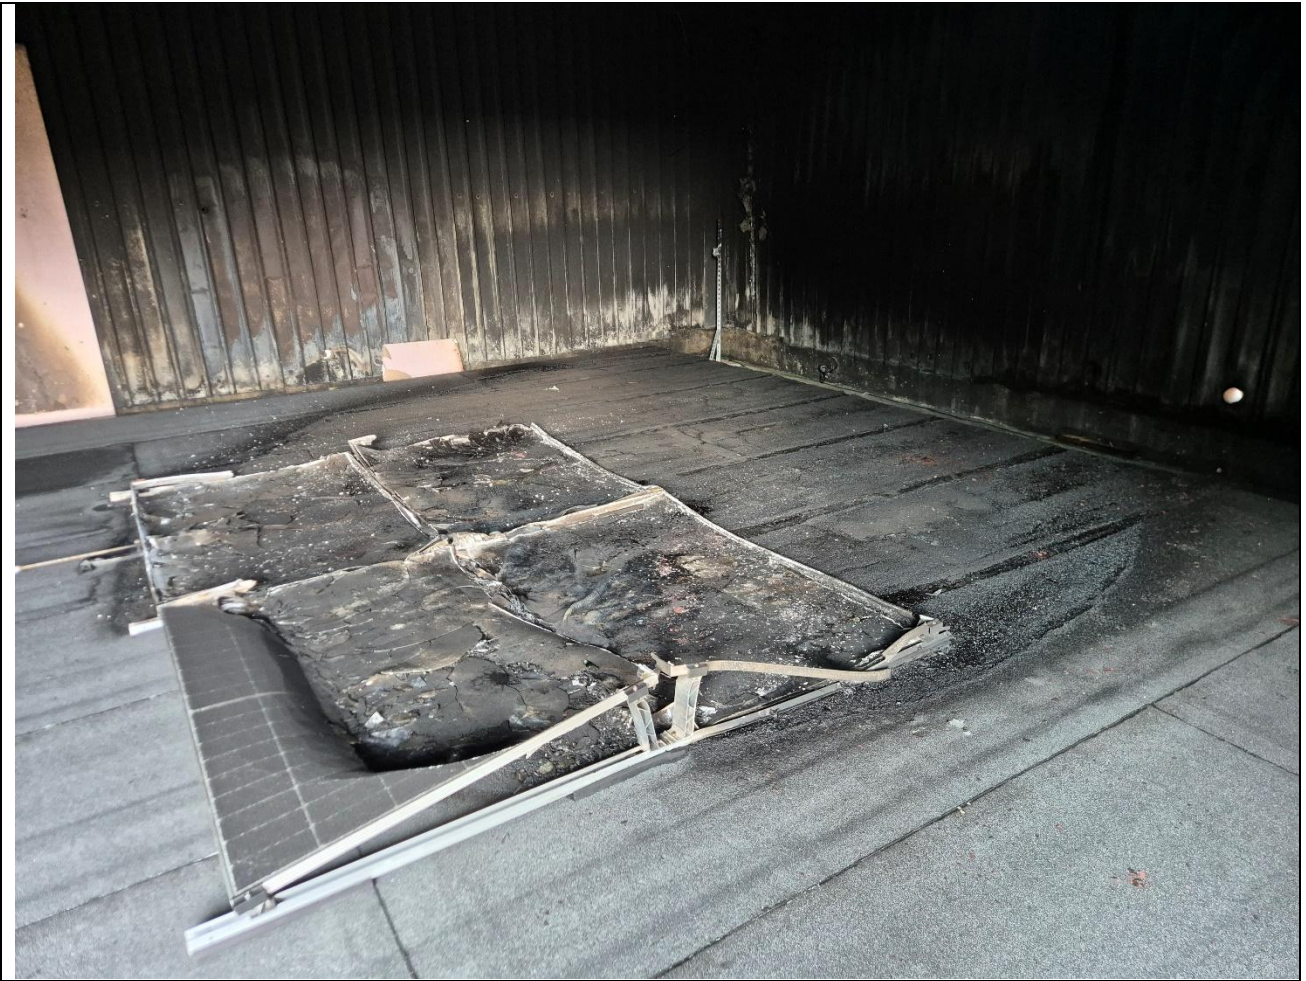
Figure 47: Damage of PV panels and roofing membrane after test with Stone wool insulation Roof.

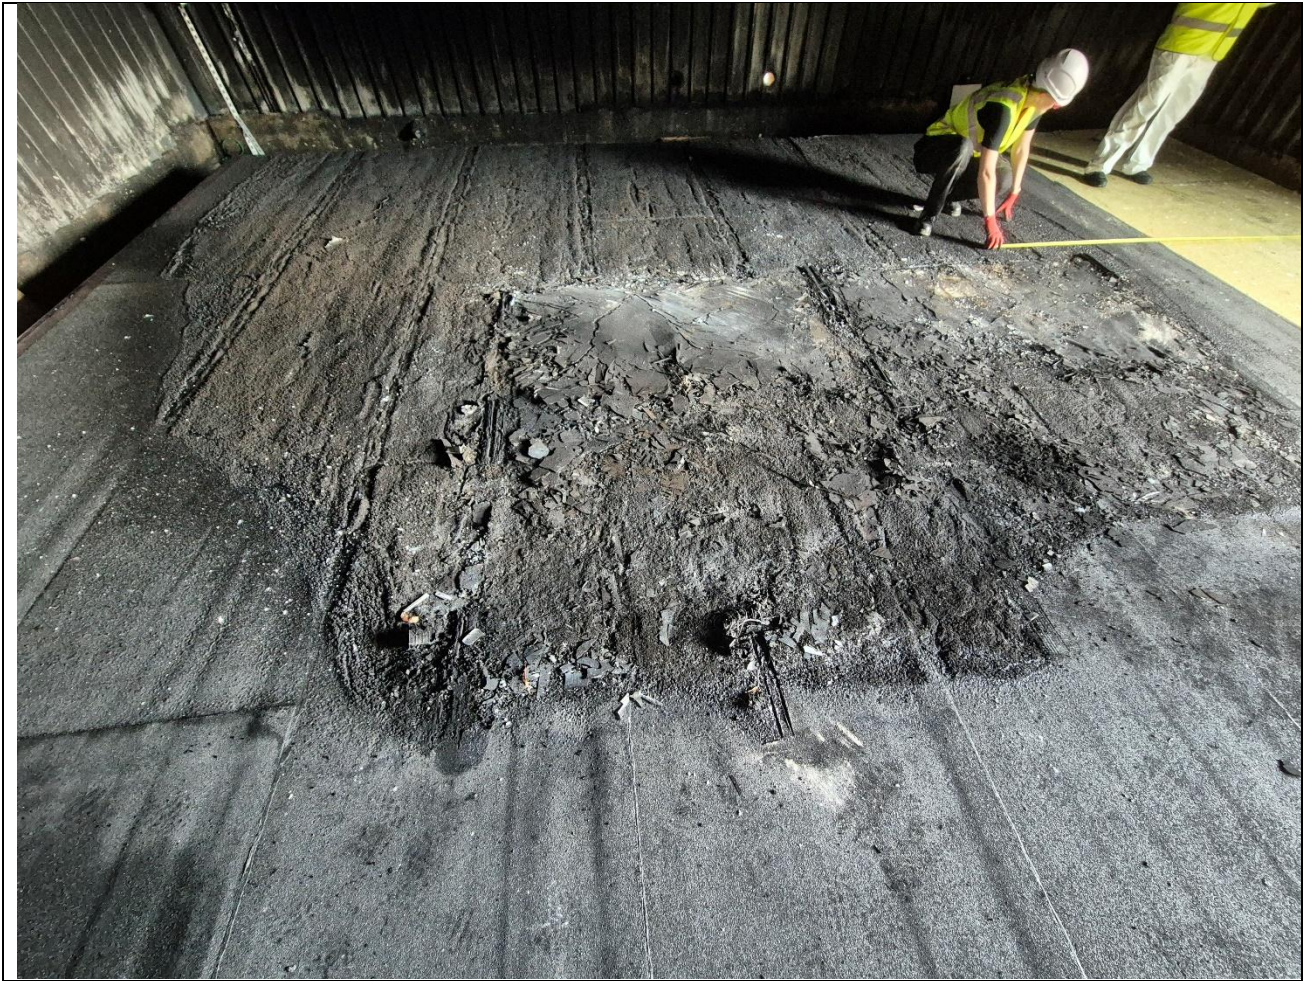
Figure 48: Damage of roofing membrane after test with Stone wool insulation roof.

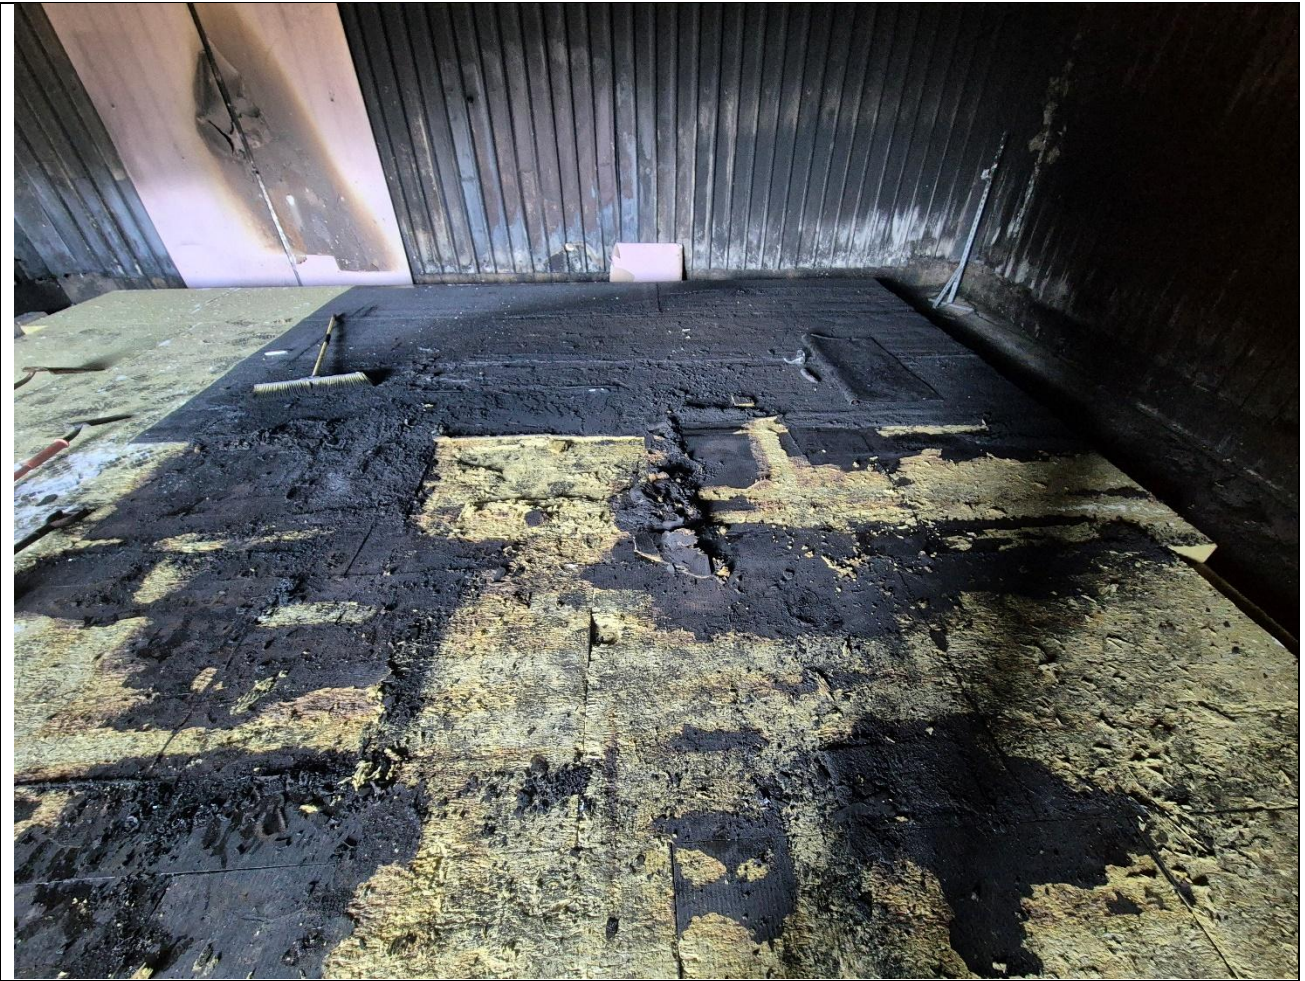
Figure 49: Stone wool insulation Roof Assembly Post-test

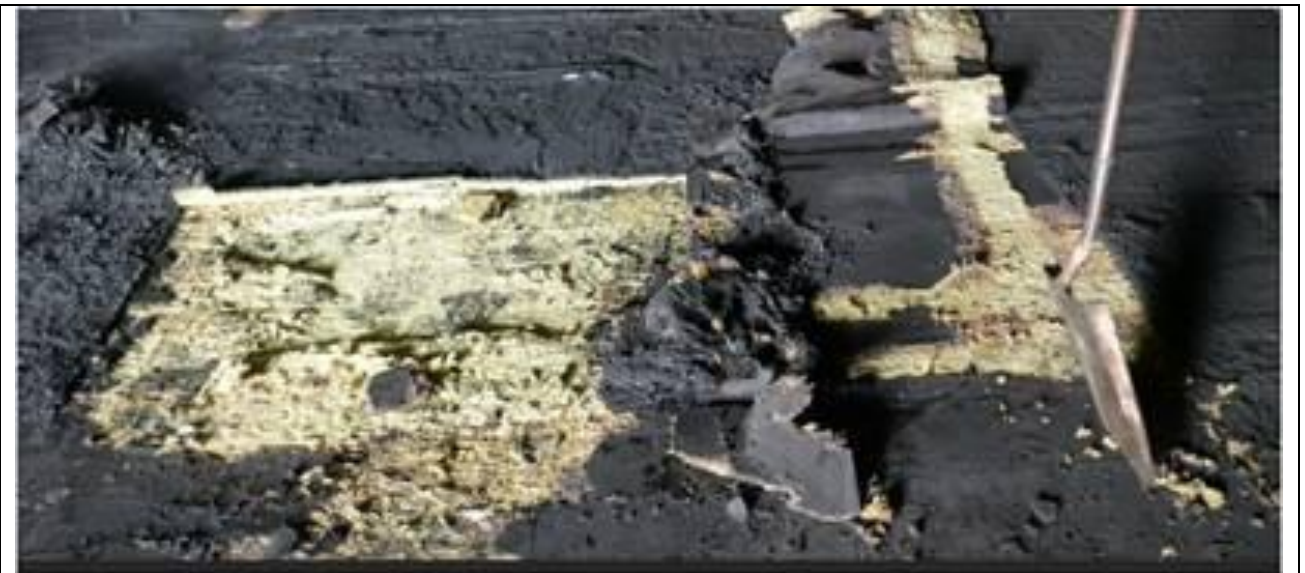
Figure 50: Charring depth within the Stone wool insulation Post-test

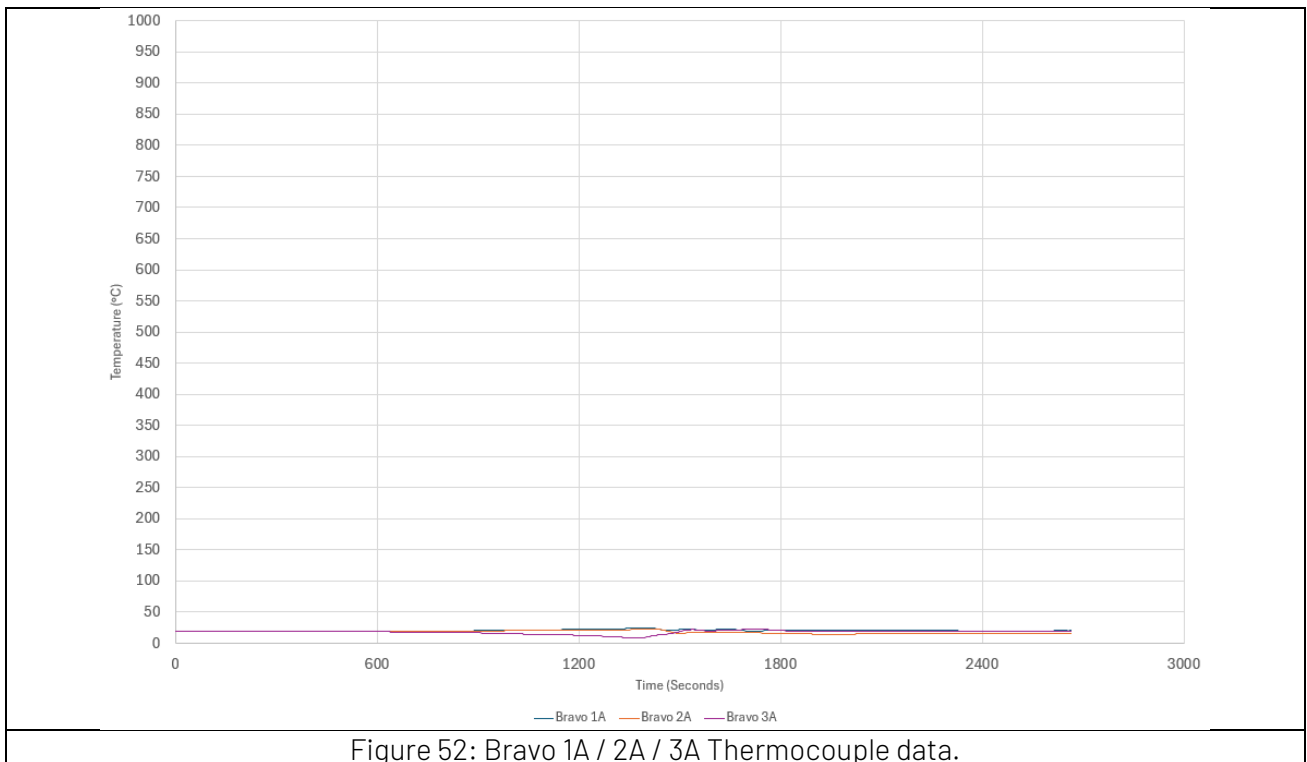
##### 4.2.4.1 Thermocouples located between the AVCL and the insulation product.

- All thermocouples in the Charlie locations recorded noticeably higher temperatures during both tests in comparison to the Alpha and Bravo locations. This could potentially be due to where the gas burner was situated, and the fire spread travelling in West and North directions.
- During the stone wool insulation test (Test 2), Charlie 3A recorded a significantly higher temperature of 1225.4°C. This could potentially be due to bitumen melting and getting between the insulation panels directly onto a thermocouple.
- During both tests, Charlie 1A and Charlie 2A had higher temperature readings than Charlie 1B and Charlie 2B. This could likely be because, although the 'A' thermocouples are located underneath the insulation layer, they are located more directly underneath the fire source. The 'B' thermocouples are spread further apart.
